# **NORTH OLMSTED WASTEWATER ANNUAL REPORT FOR 2015**

## 2015 PROJECT PHOTOS

## 2015 Collection System And Stormwater Improvements

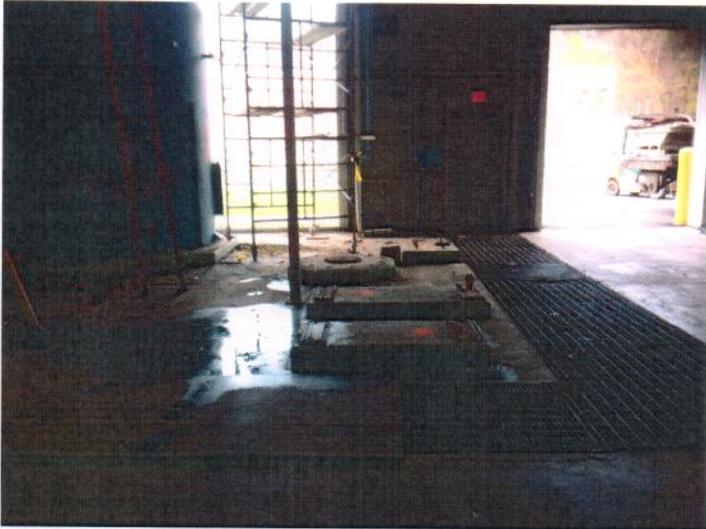
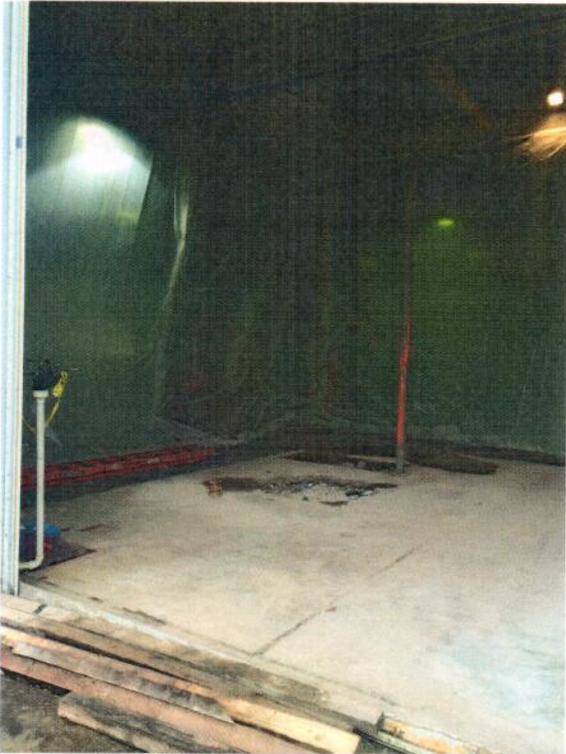
Plant  
Zimpro Area Renovation Project

- Worked to minimize sludge produced by the treatment plant through extended solids holding times. (approx. \$7,500 in polymer savings)
- Completed demolition in the Zimpro area making room for the new shower, locker room and crew conference/ training area.

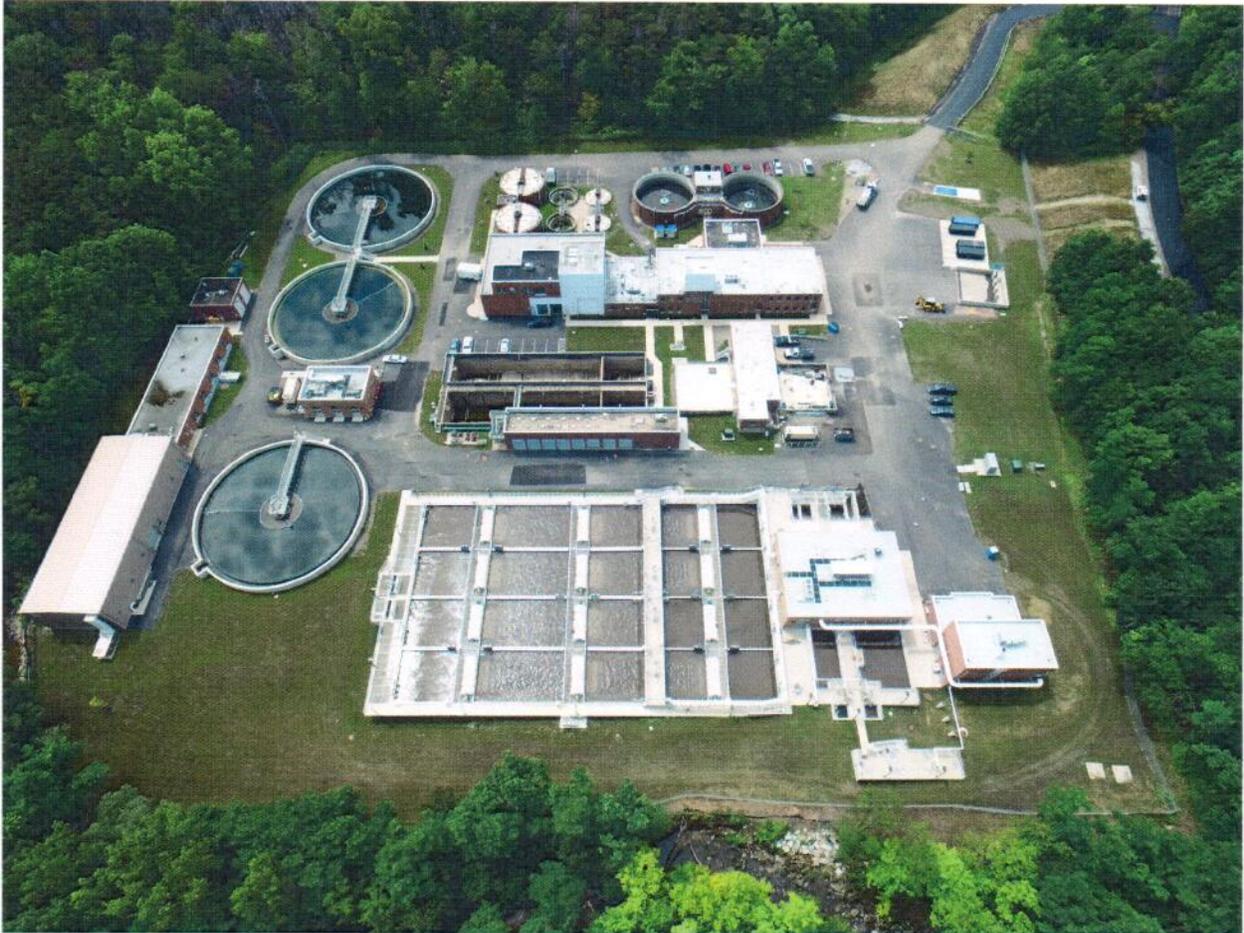
## Plant Phase 2 Improvements Complete

- Finished Phase 2 WWTP construction.
- Started energy curtailment program with Enternoc (payments of \$4,377.07 on 8/31/15 and \$13,187.25 on 11/16/15)

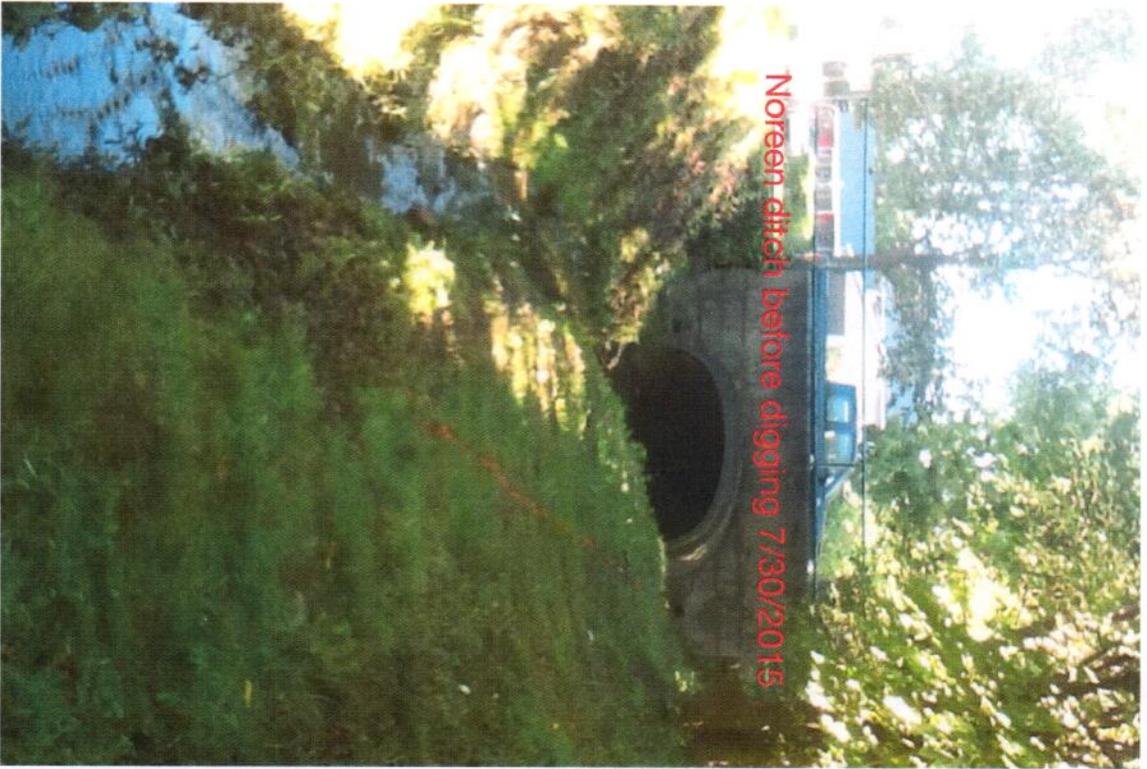
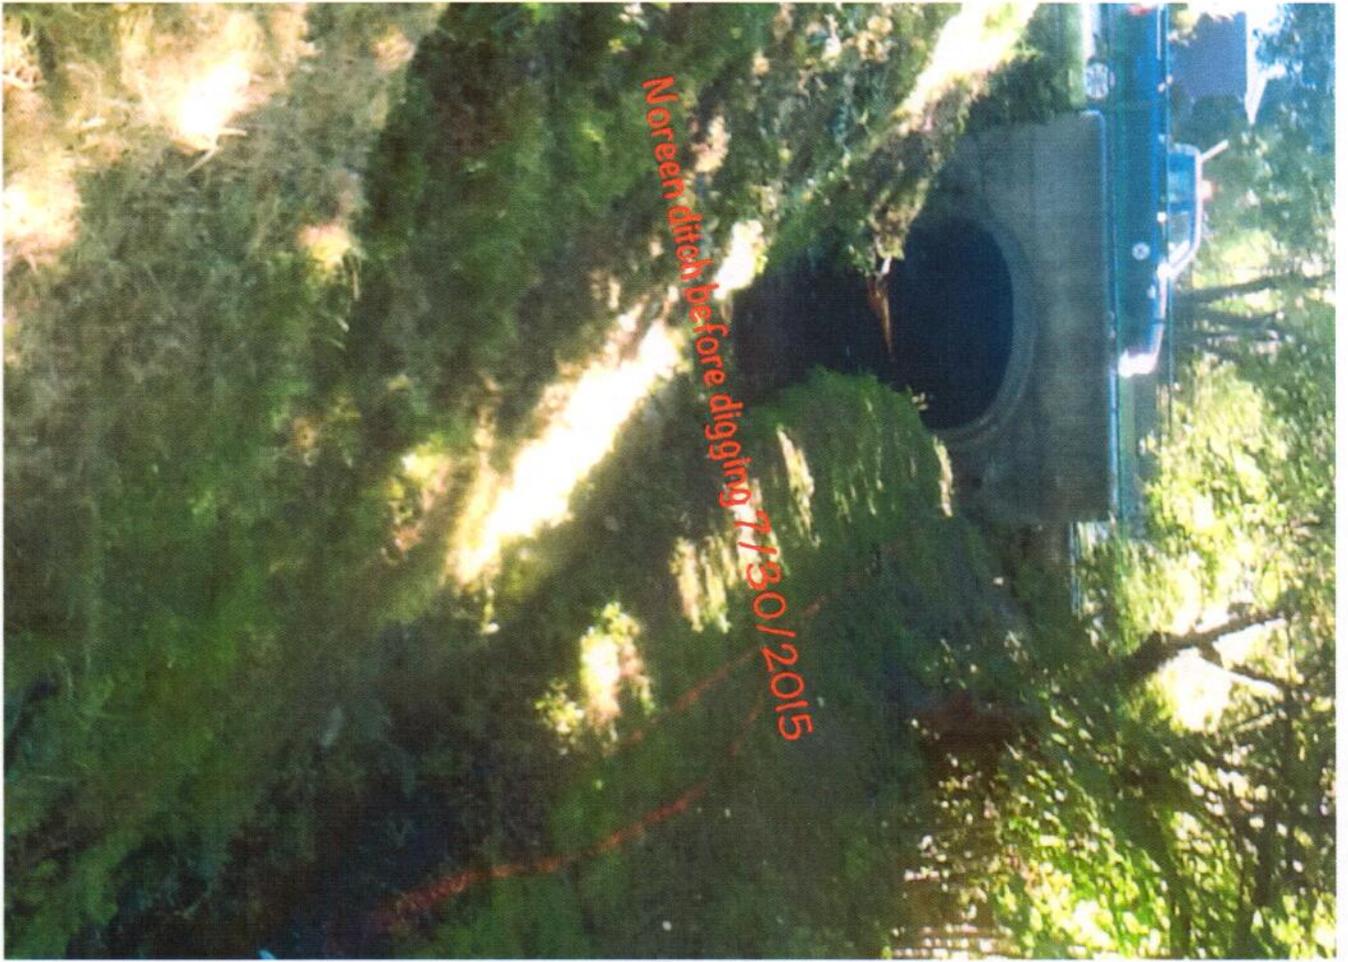
Noreen ditch before digging 7/30/2015

- Major reconstruction projects for stormwater were conducted in Noreen Ditch and the South Barton Ditch from Barton to I-480.
  - Smaller stormwater projects included Pine School Ditch and improvements at the North Olmsted Recreation Center.

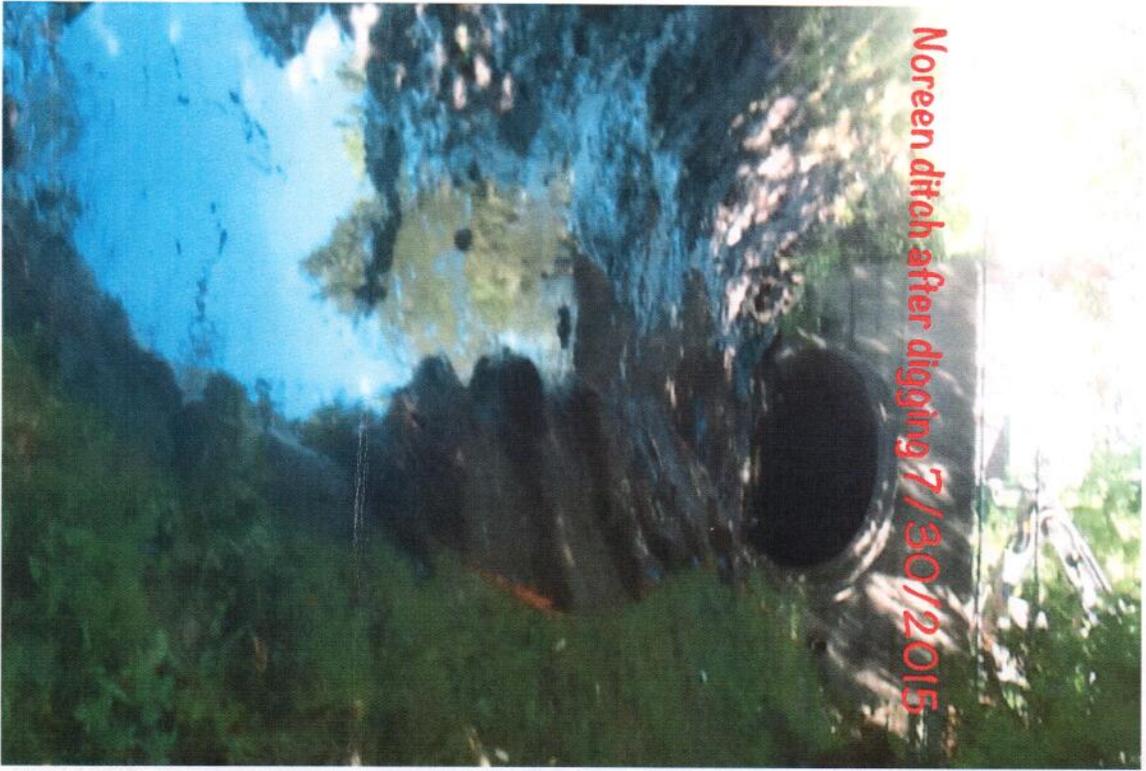
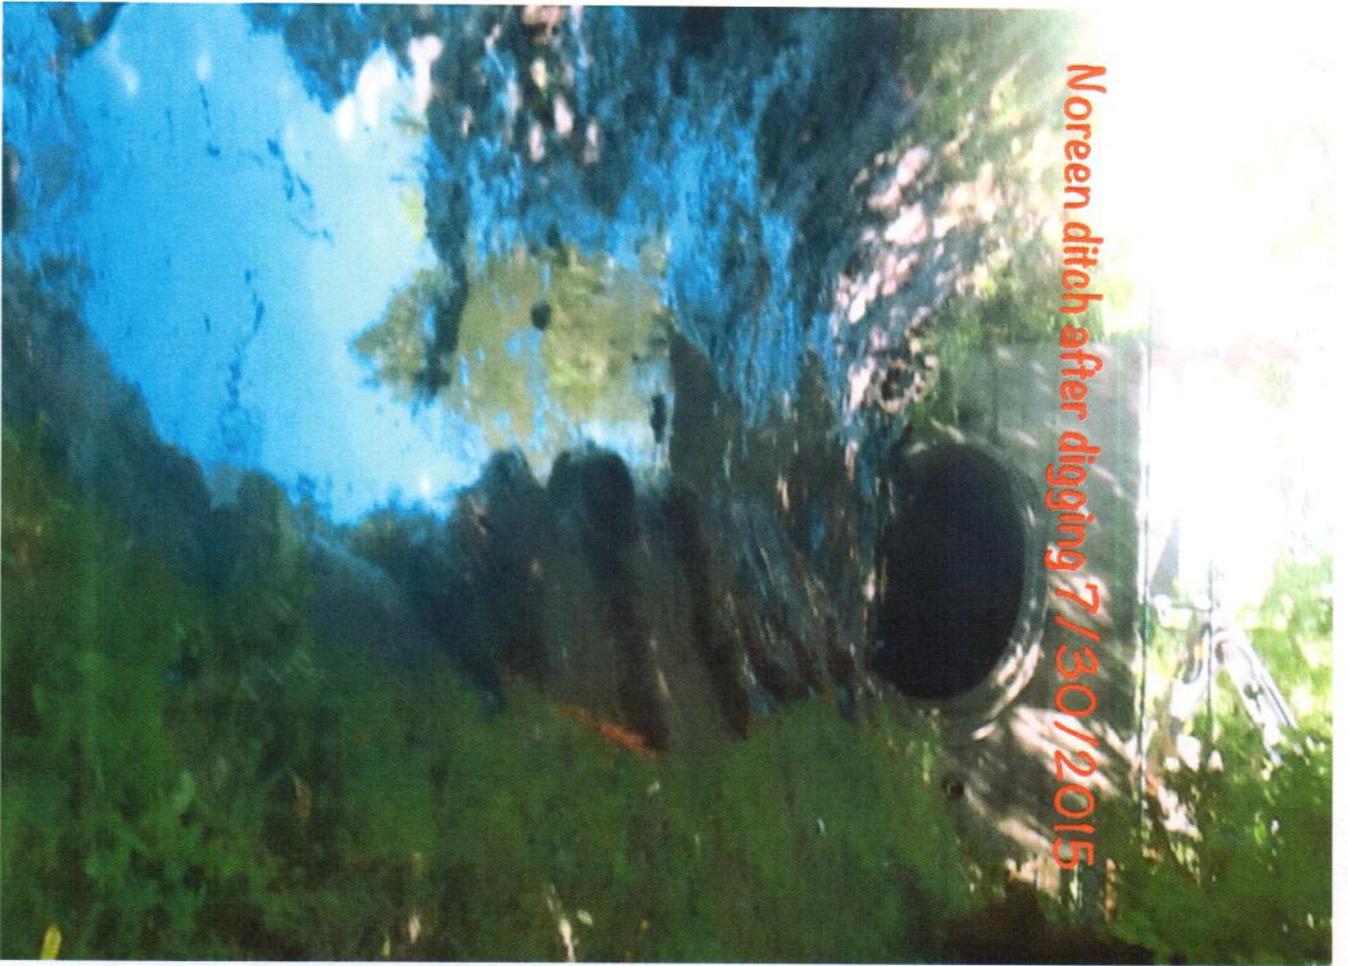
Noreen ditch after digging 7/30/2015

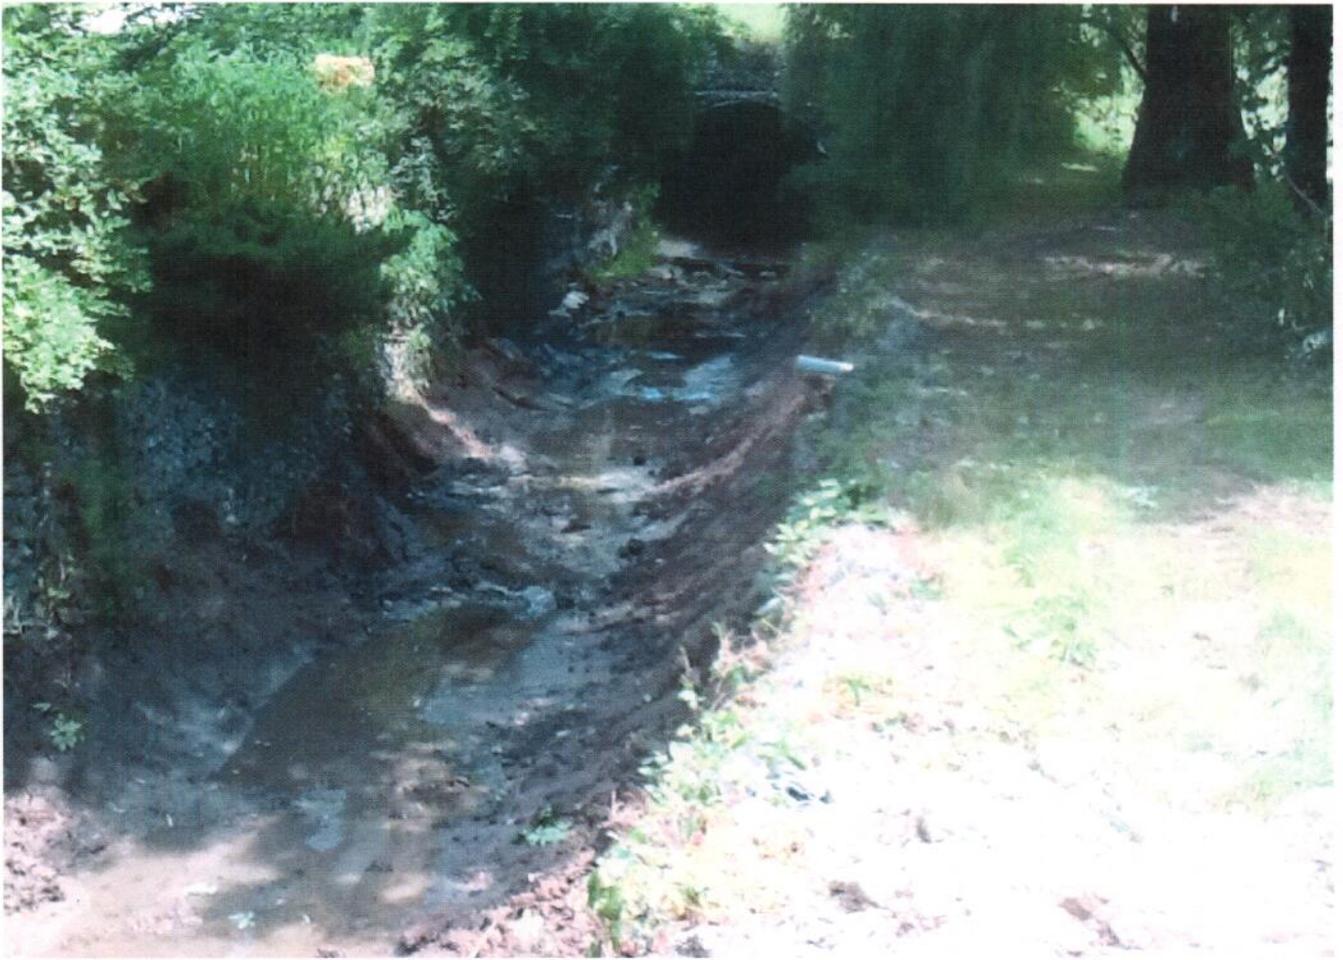
July 2015 7000 Barton Rd.

7000 BARTON RD. DUG UP ALL GABION  
BASKETS INSTALLED NEW SILT FABRIC

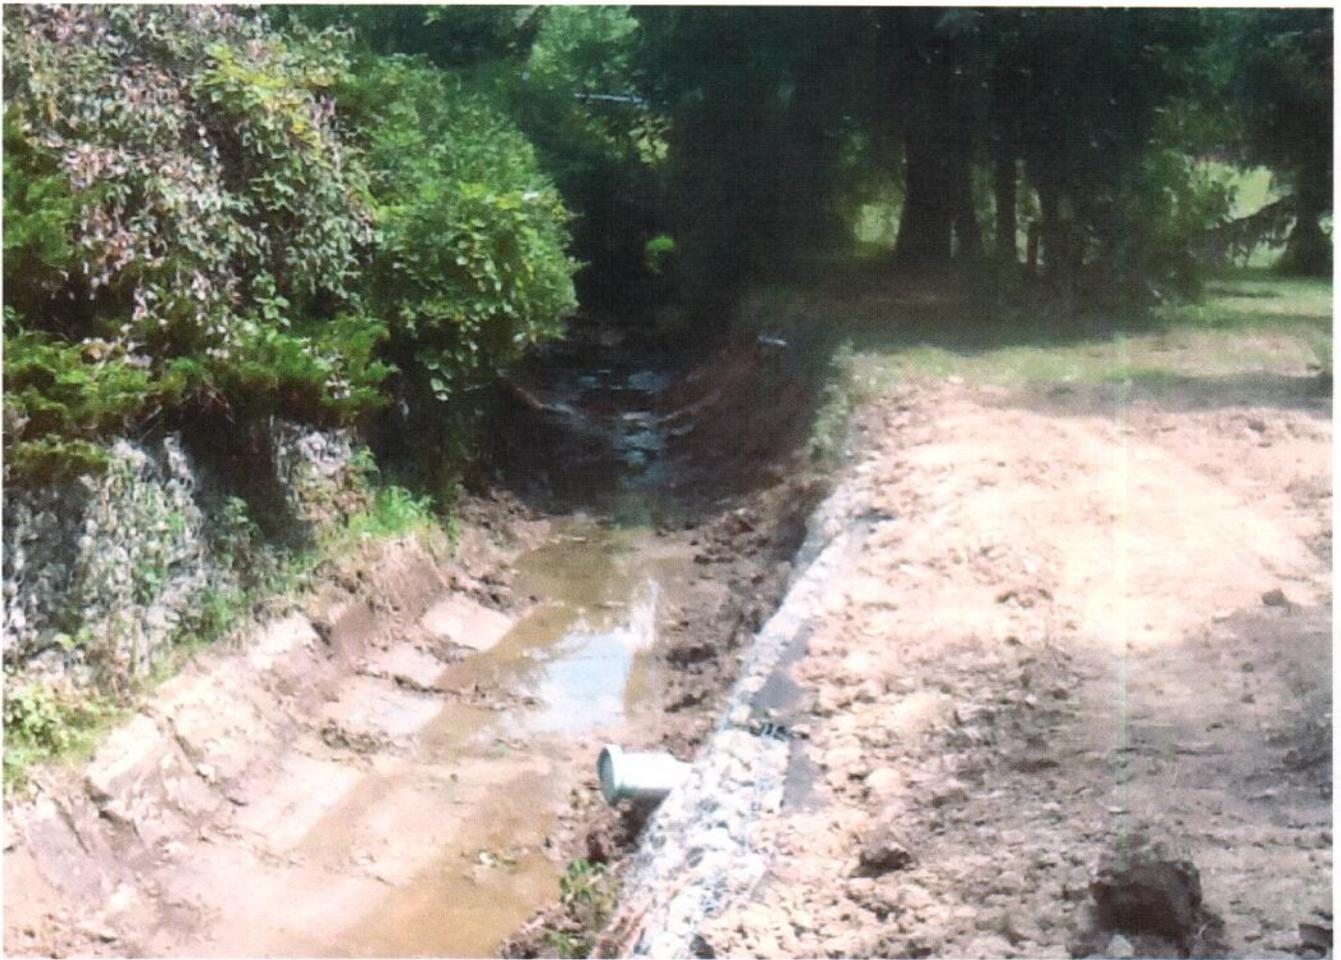
JULY 2015 7000 BARTON Rd

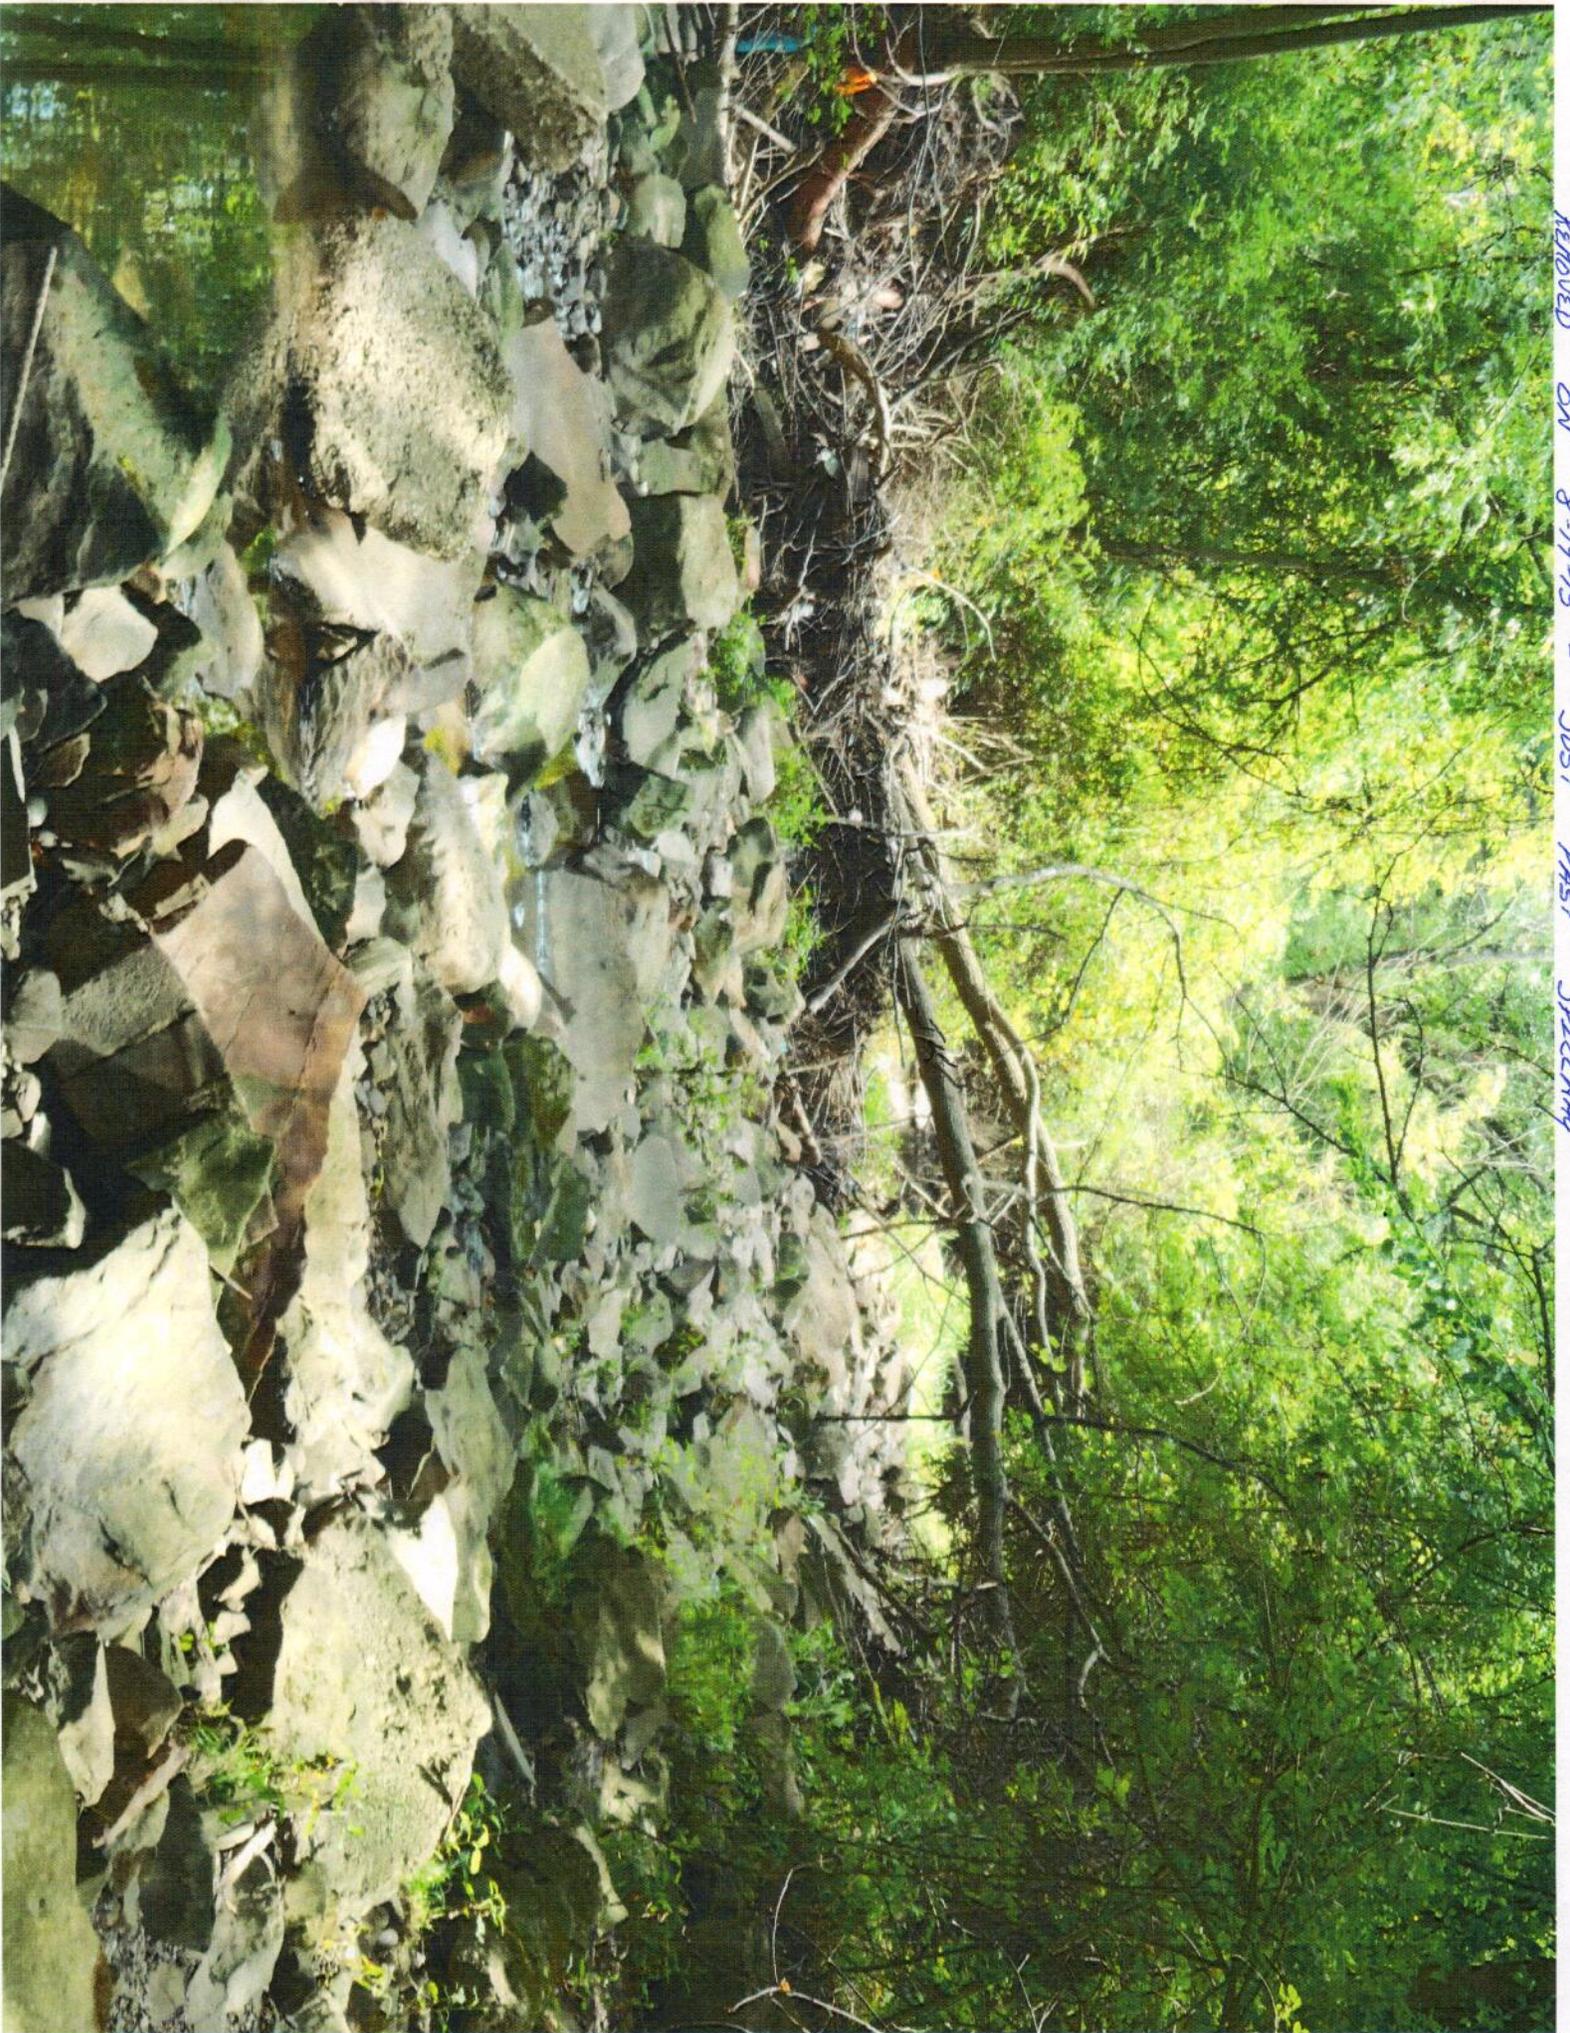
REMOVED ON 8-19-15 - JUST PAST SPELLING

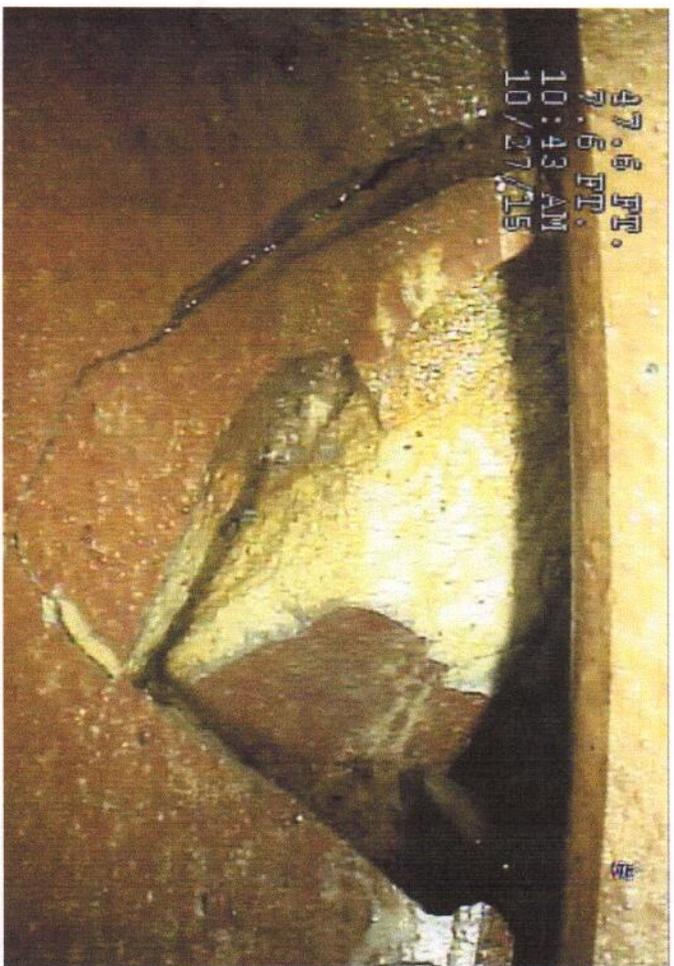
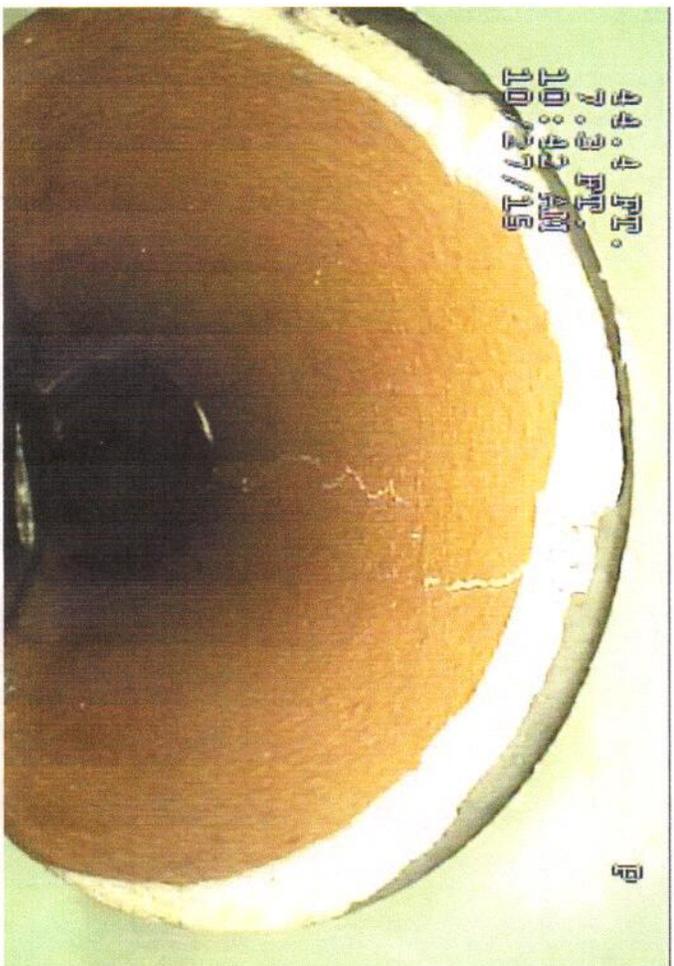
24020 BEAMSOUT MH # 1-180402 TO 1-180403

BEFORE

- Sewer mains cracks, offsets, breaks and repairs were located by our CCTV crews. All repairs were done in-house with our trenchless technology patch equipment with the exception of two which were contracted out due to depth or hazards.

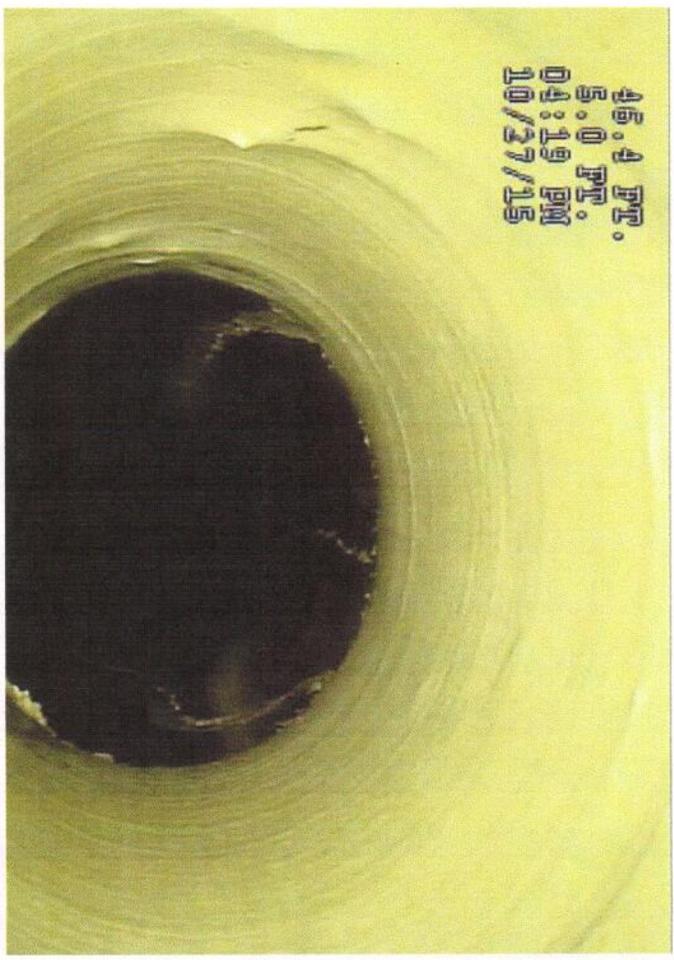
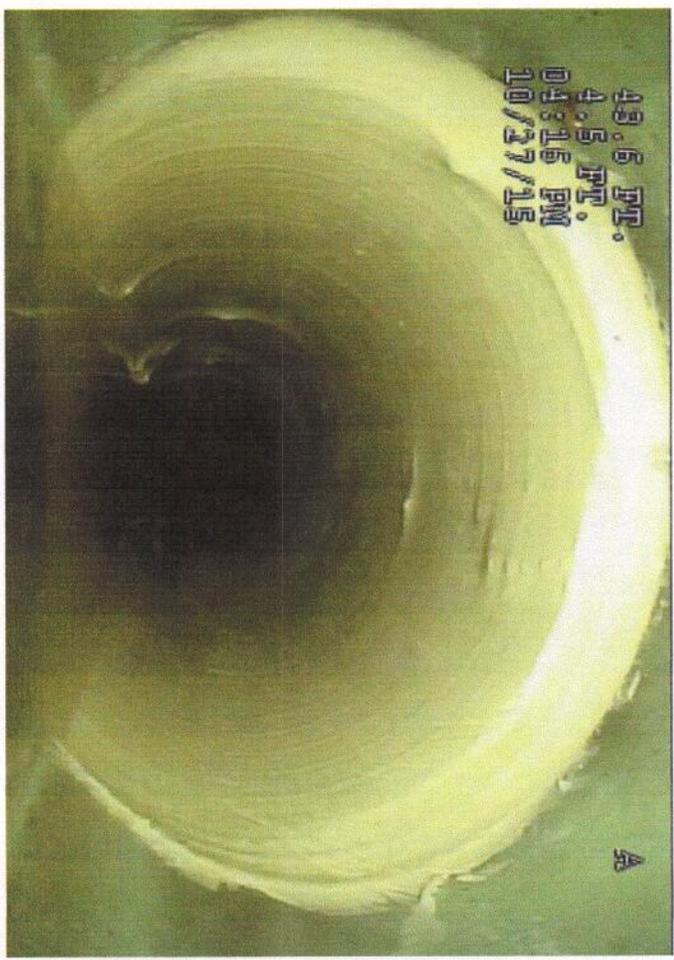
AFTER

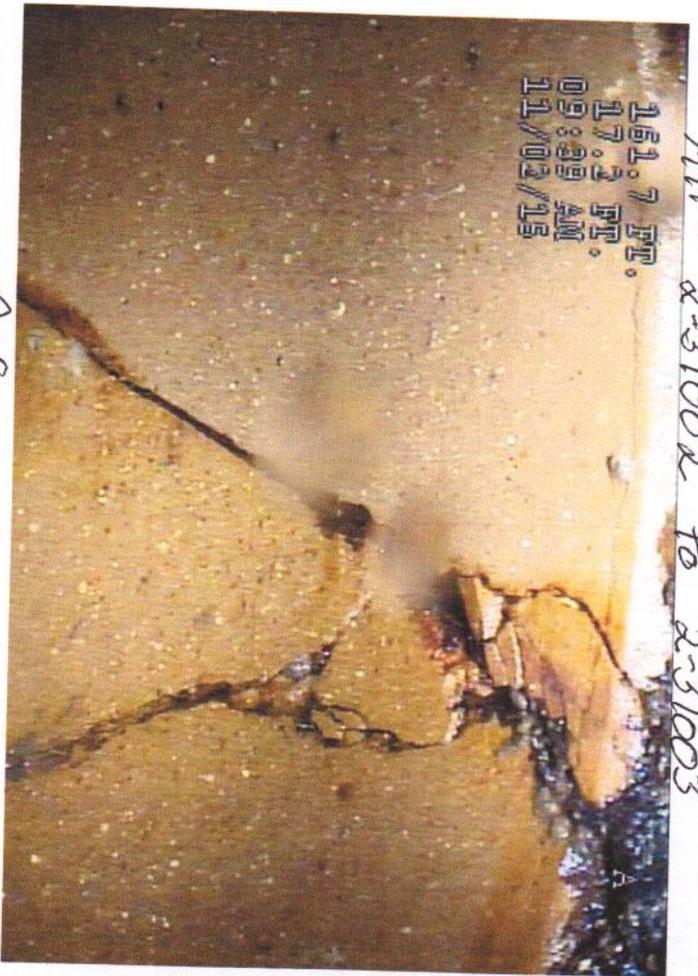
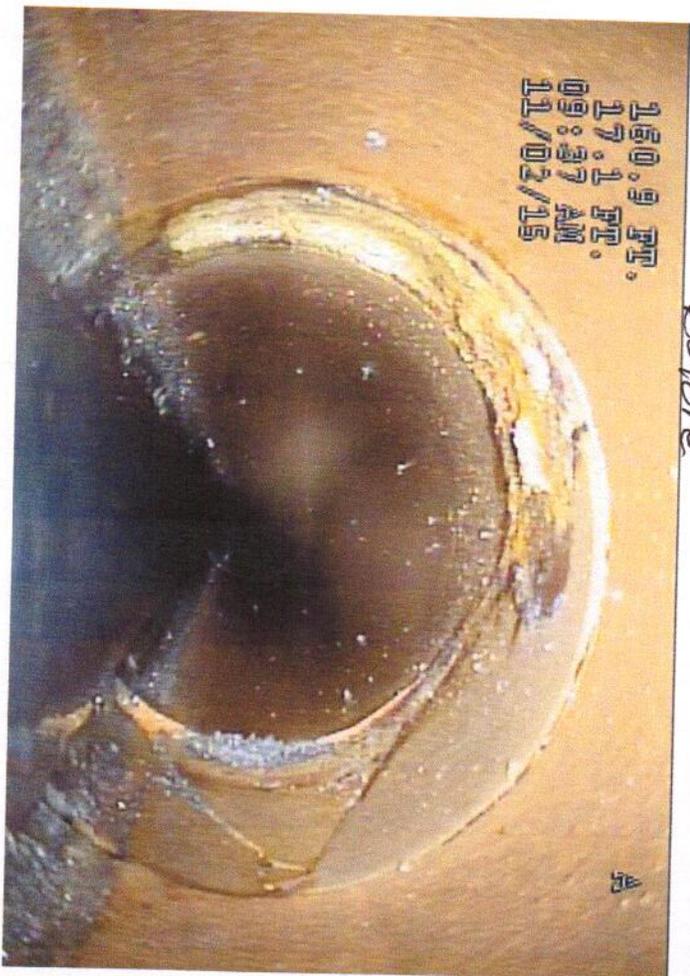
MH # 2-31002 to 2-31003

Before

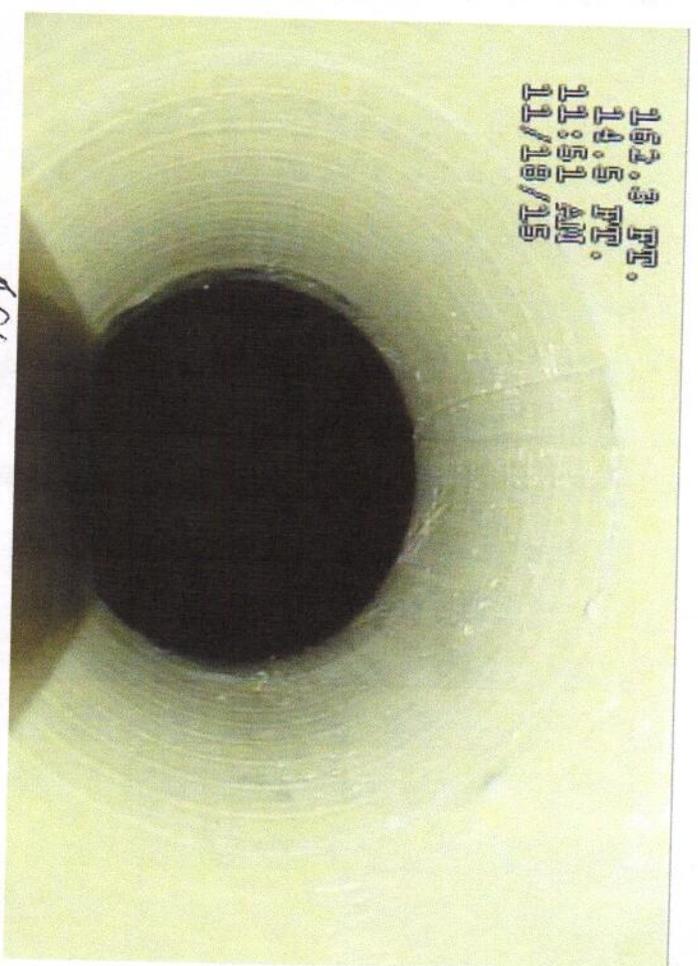
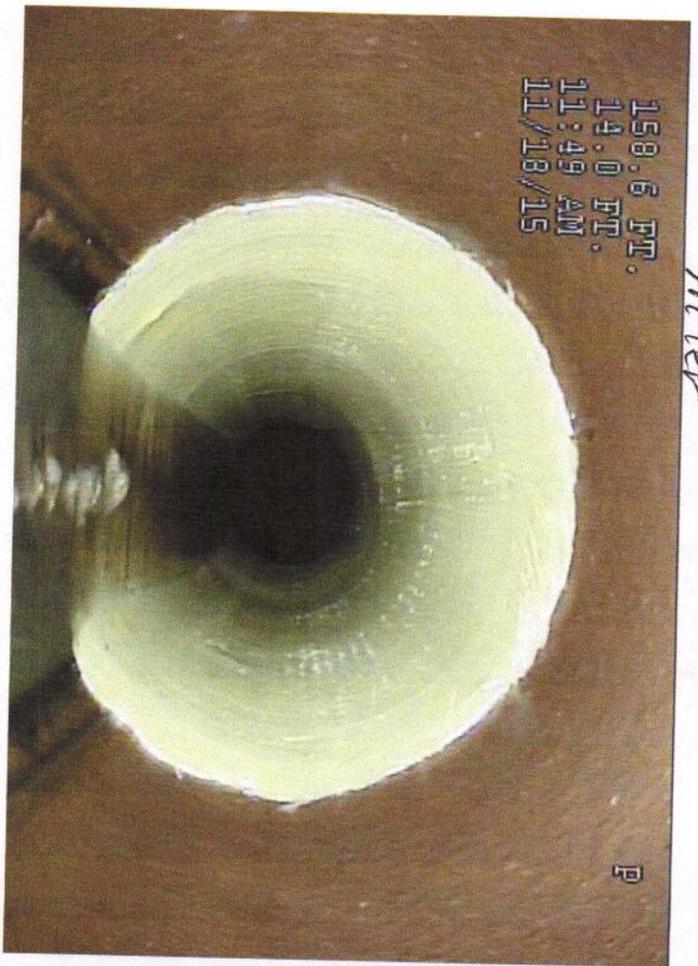
After

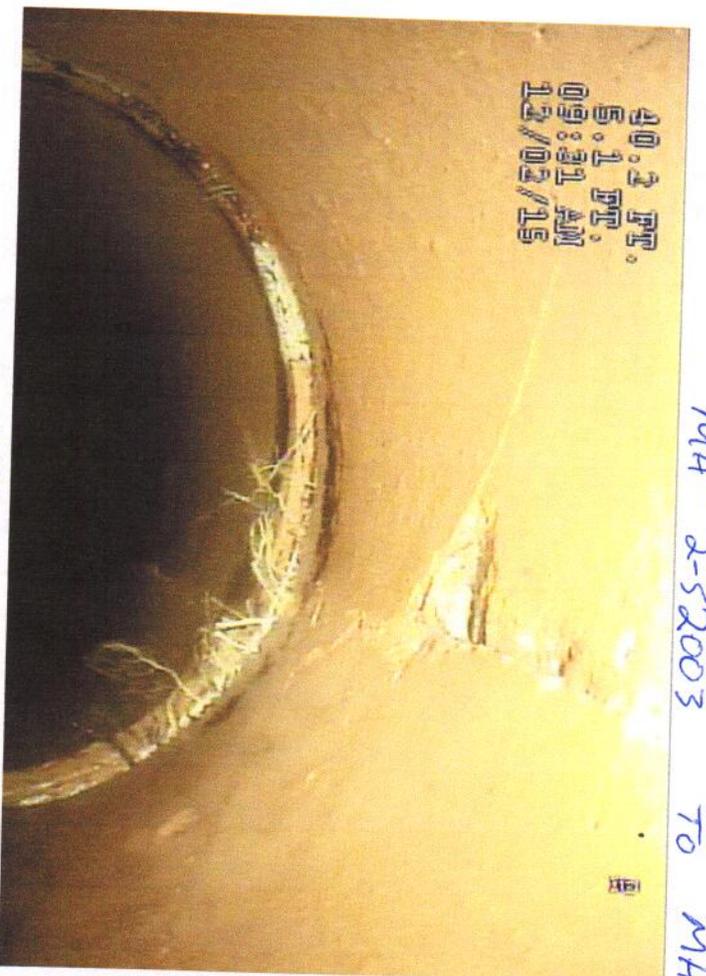
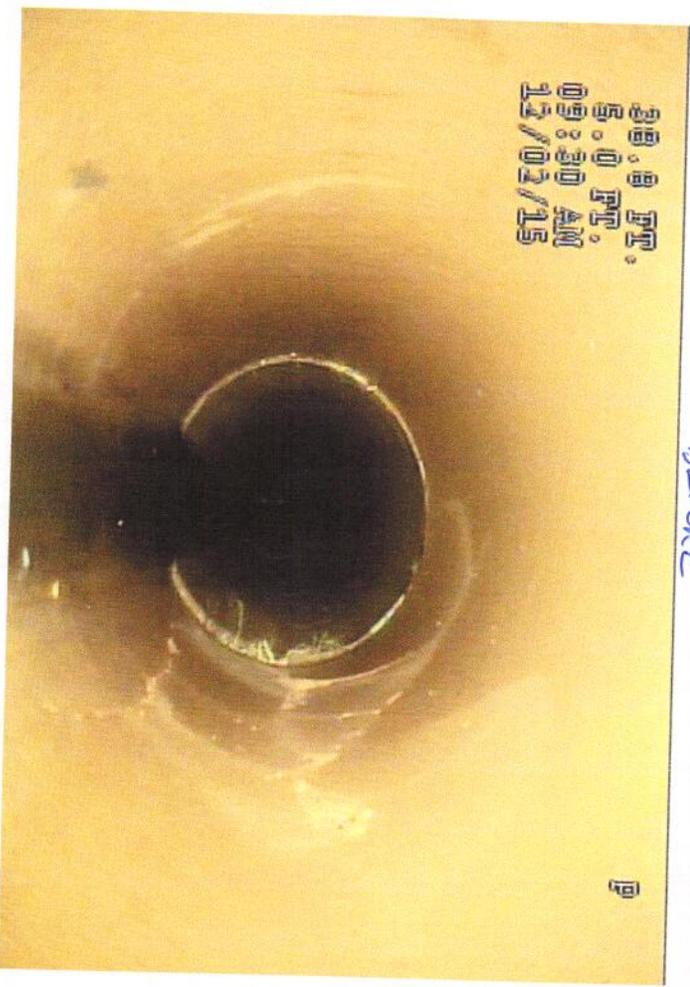
PIPE PATCH 27930 ANDORRA  
MH # 2-32003 TO MH # 2-32201

BEFORE

PATCH #2

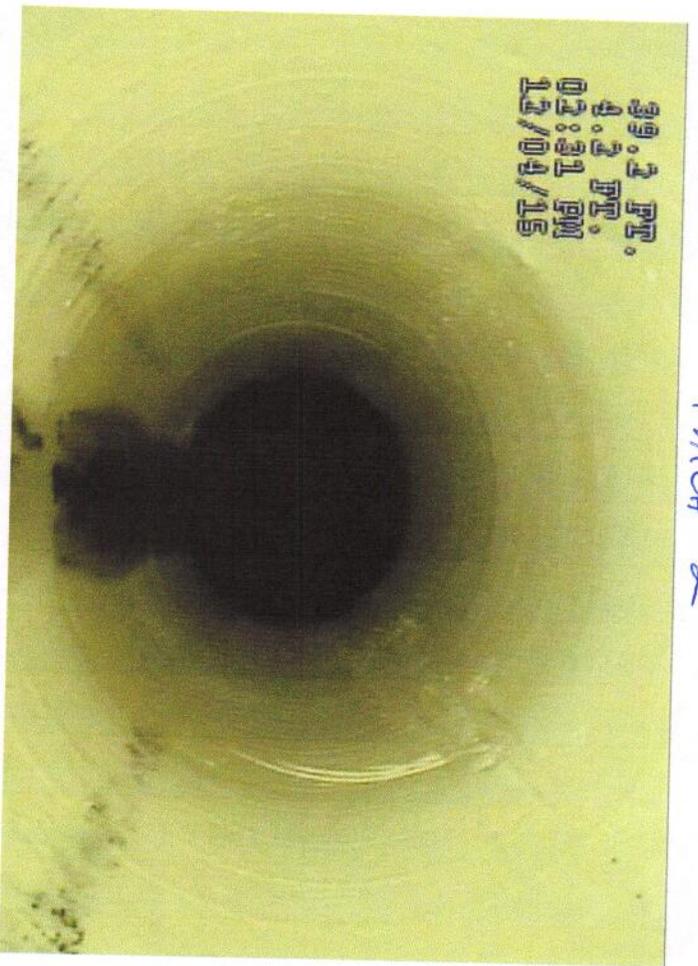
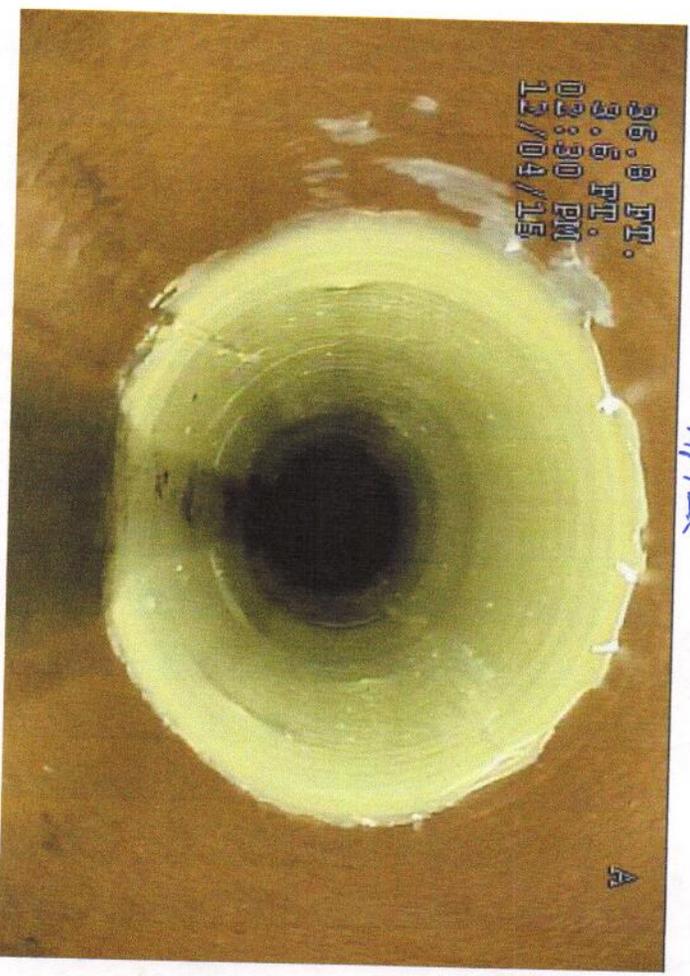
AFTER

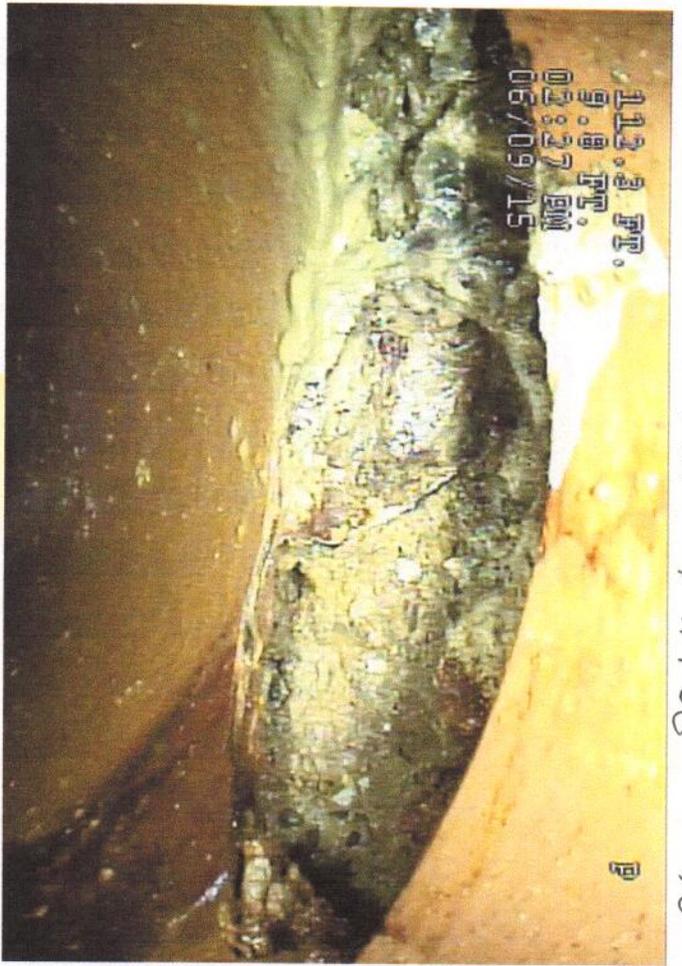
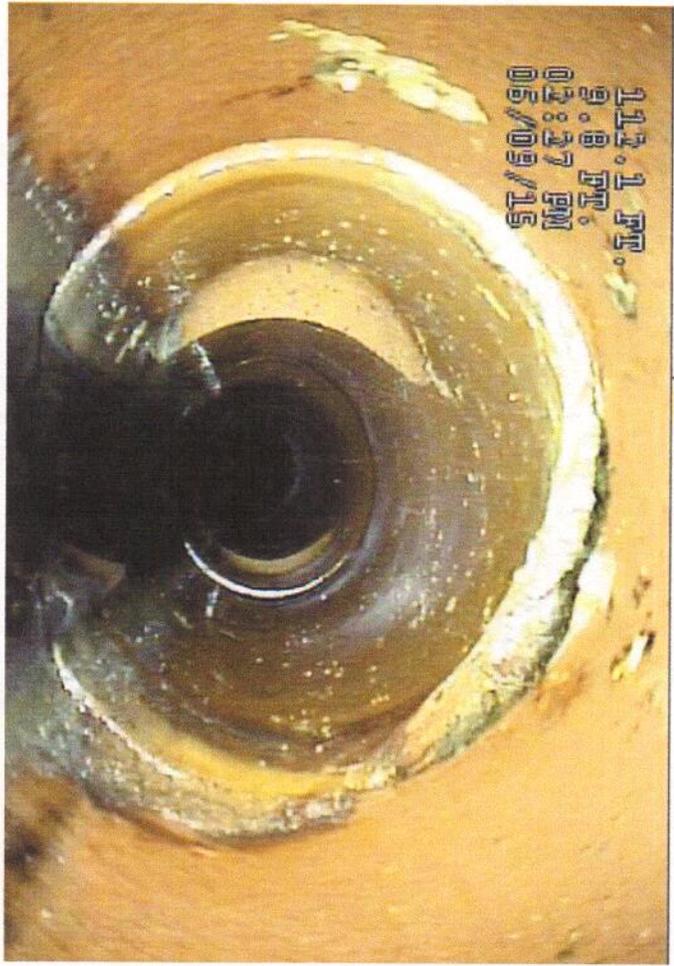
23326 SHARON  
MTH # 1-11706 TO

BEFORE

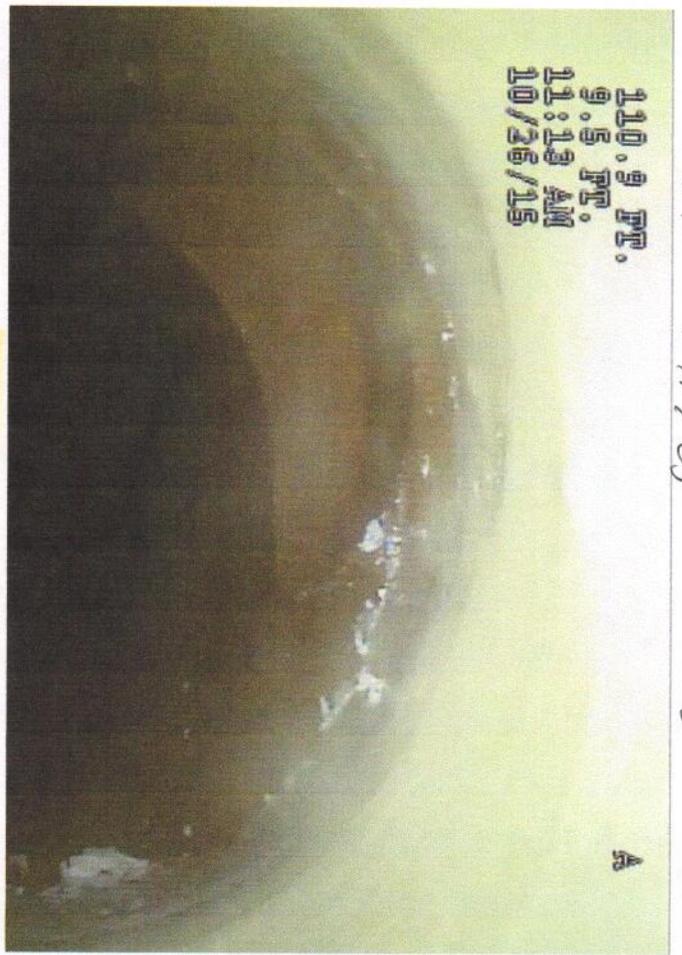
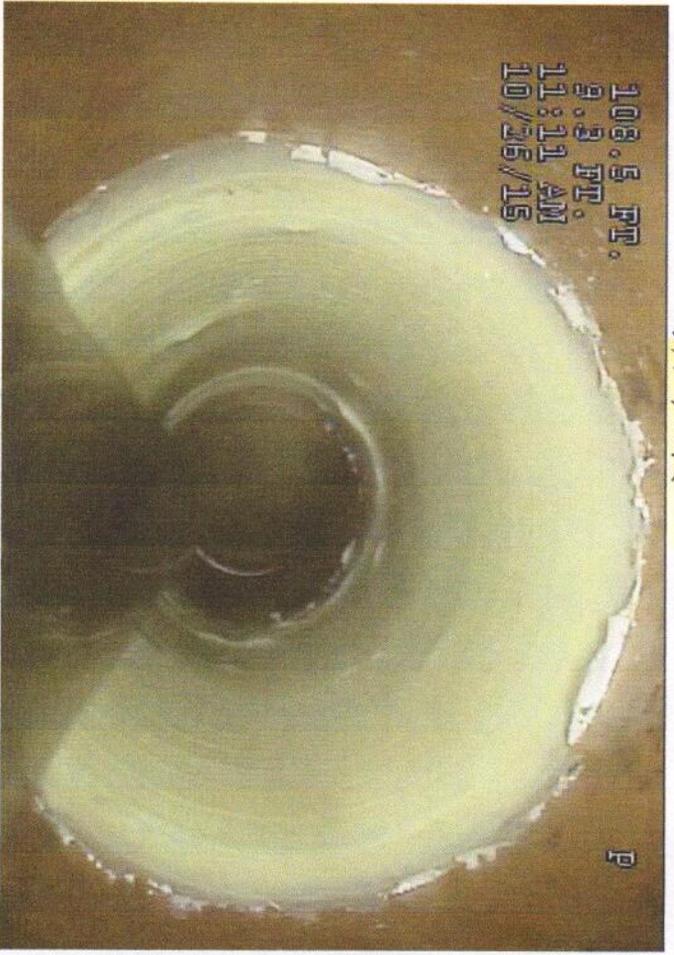
AFTER
