# **NORTH OLMSTED WASTEWATER ANNUAL REPORT FOR 2015**

## 2015 PROJECT PHOTOS

## 2015 Collection System And Stormwater Improvements

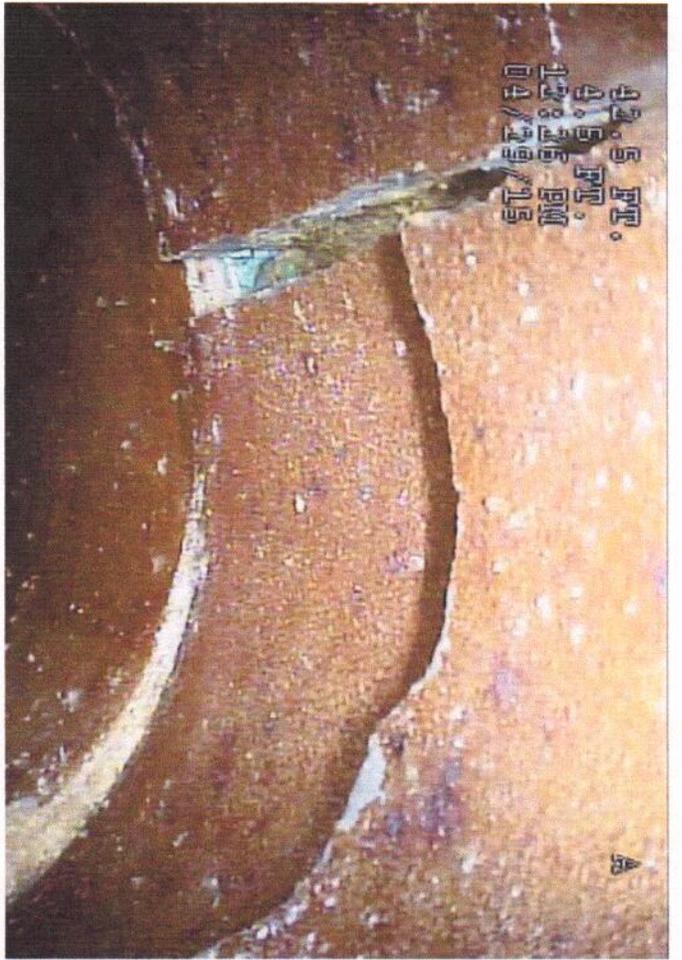
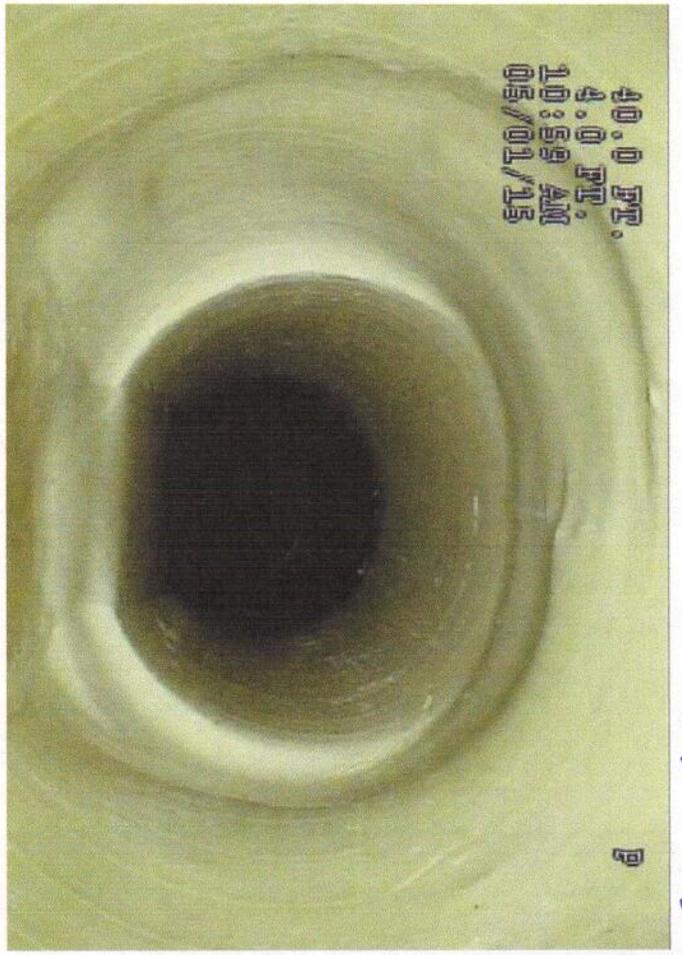
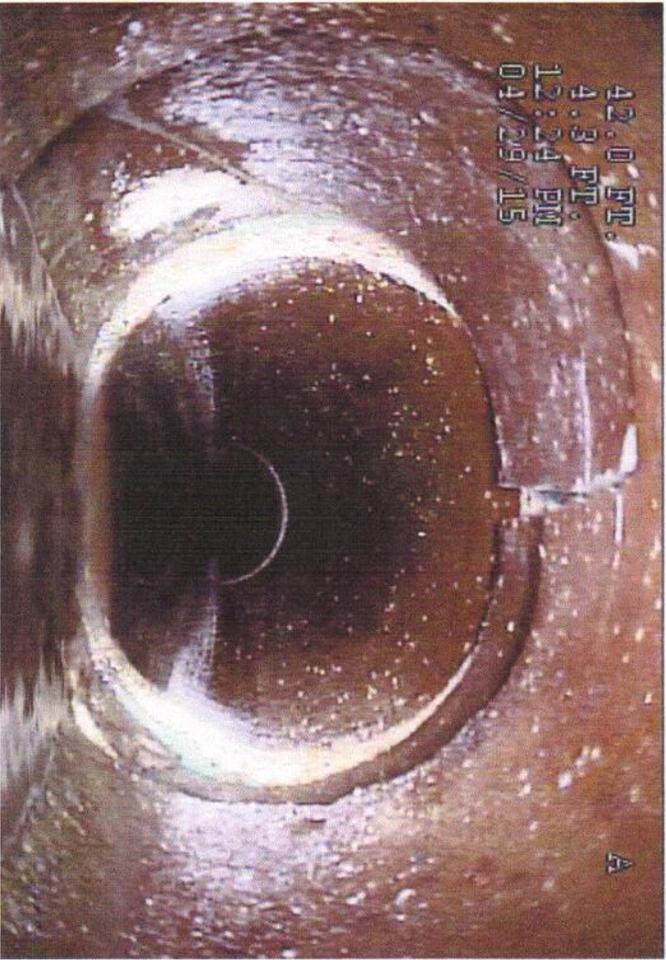
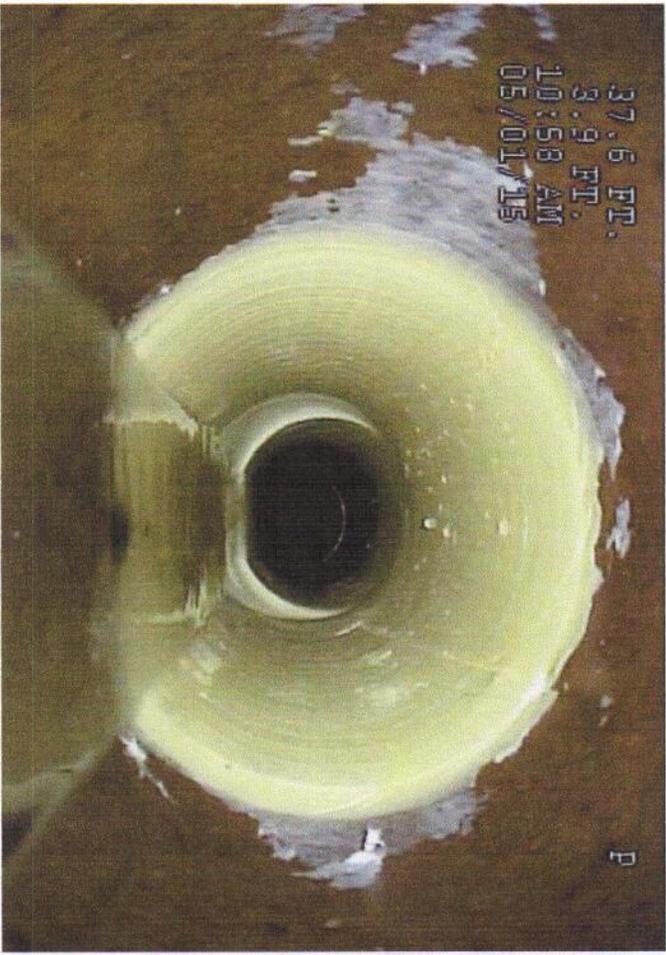
6023 FOREST RIDGE - PIPE PATCH

BEFORE

AFTER

- Sewer mains cracks, offsets, breaks and repairs were located by our CCTV crews. All repairs were done in-house with our trenchless technology patch equipment with the exception of two which were contracted out due to depth or hazards.

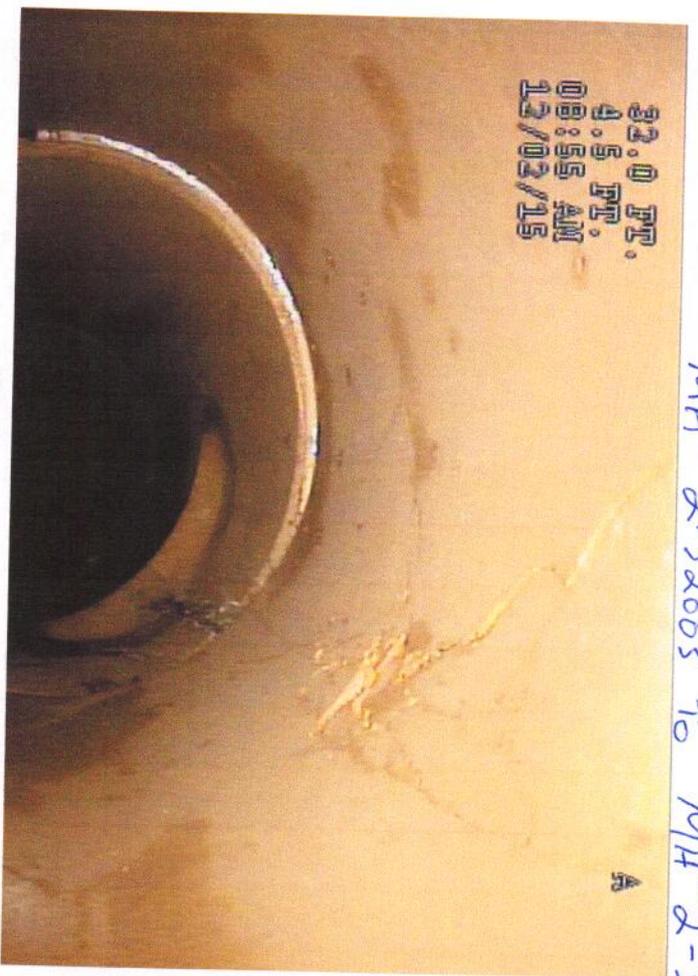
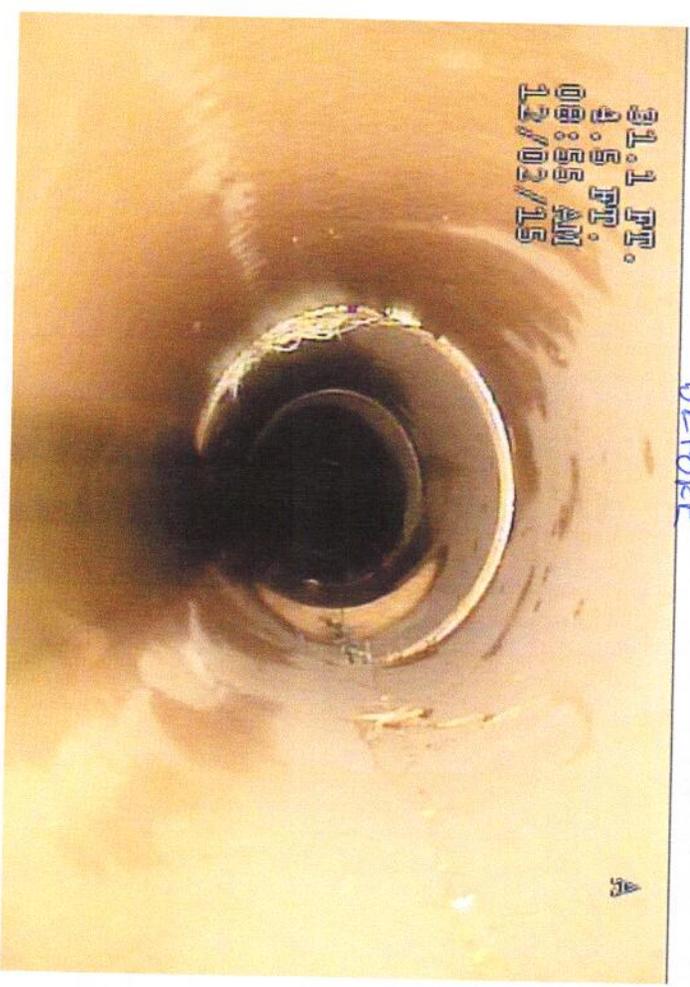
PIPE PATCH 27930 ANDORRA  
MH # 2-32003 TO MH # 2-32201

PATCH # 1

BEFORE

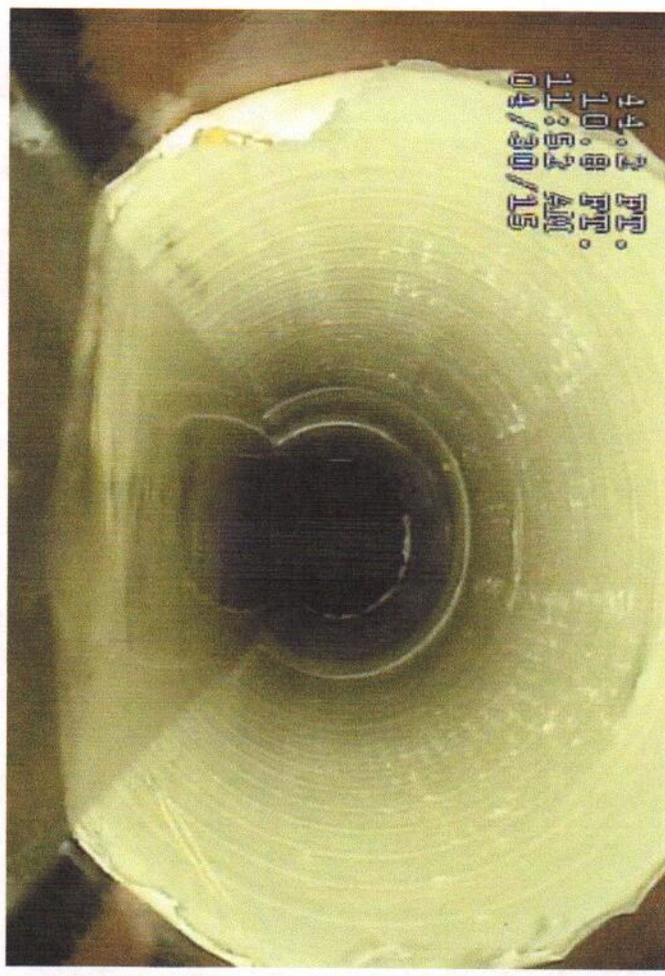
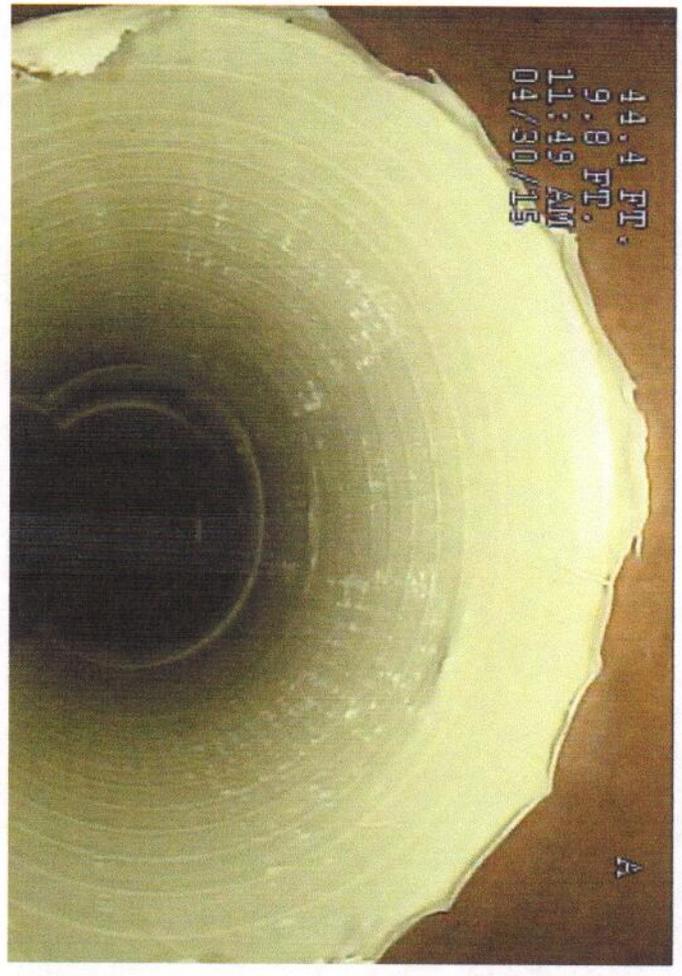
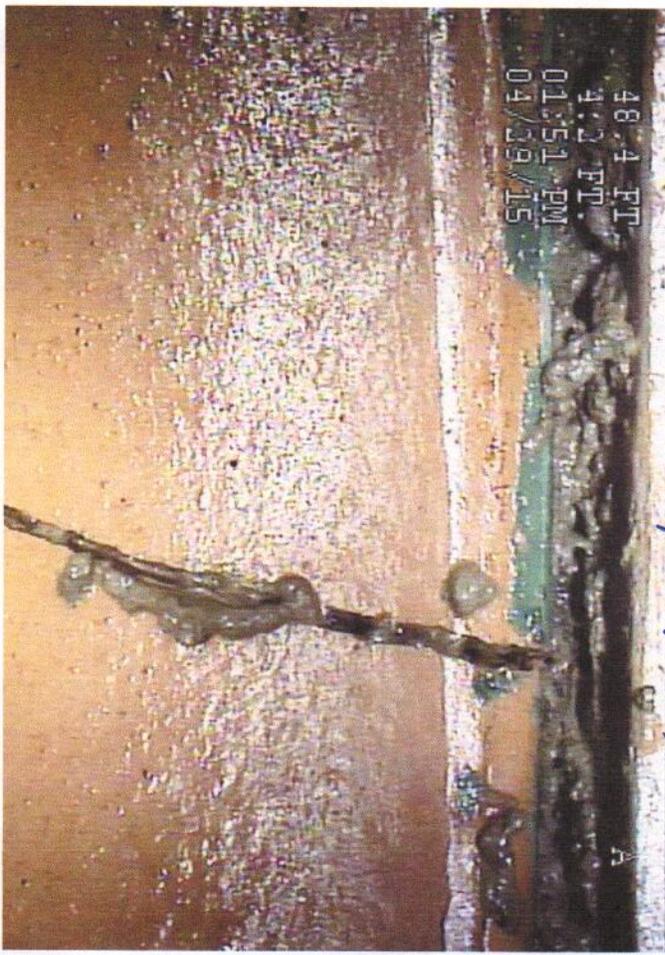
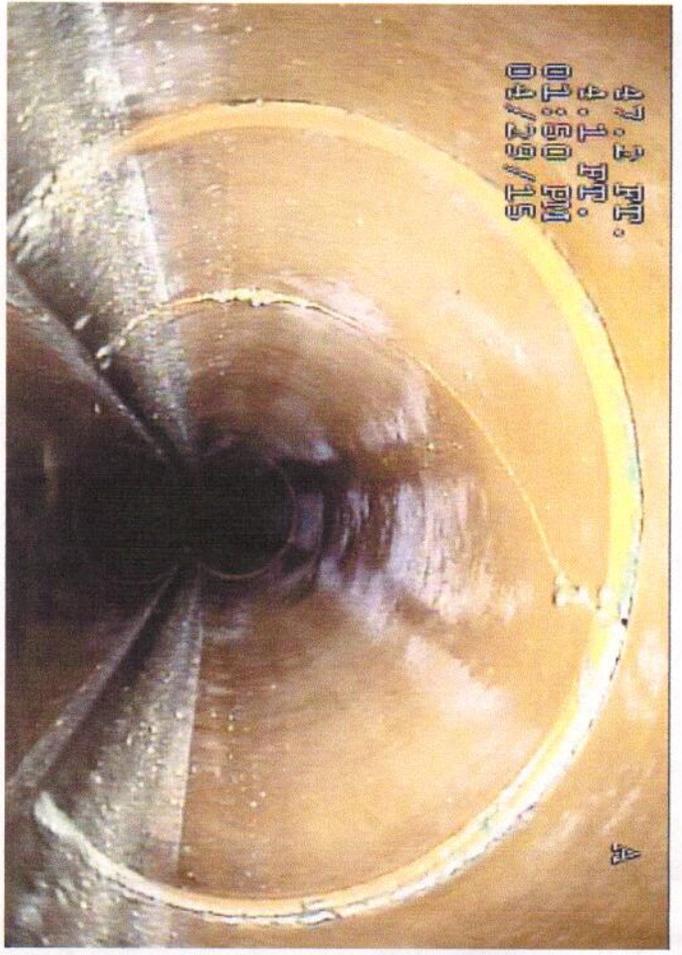
5974 Carreau Pipe Patch 4-30-15

MH# 3-20301 TO MH# 3-20302
