Clague Road Corridor Study

Clague Road from Lorain Road to the Westlake
City Line

October 6, 2020

City of North Olmsted
5200 Dover Center Road
North Olmsted

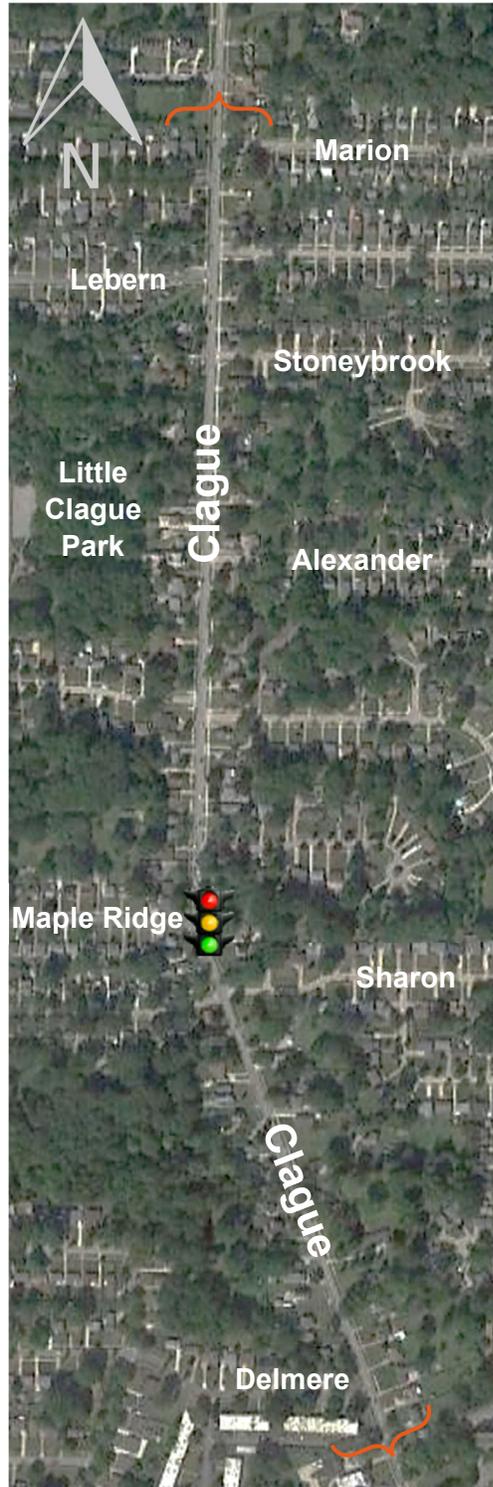
Figure 1 - Clague Road Corridor Study Area

The Clague Road Corridor Study extends approximately 0.9 miles along Clague Road from just north of Lorain Road to the Westlake City Limits in eastern North Olmsted, OH (Figure 1).

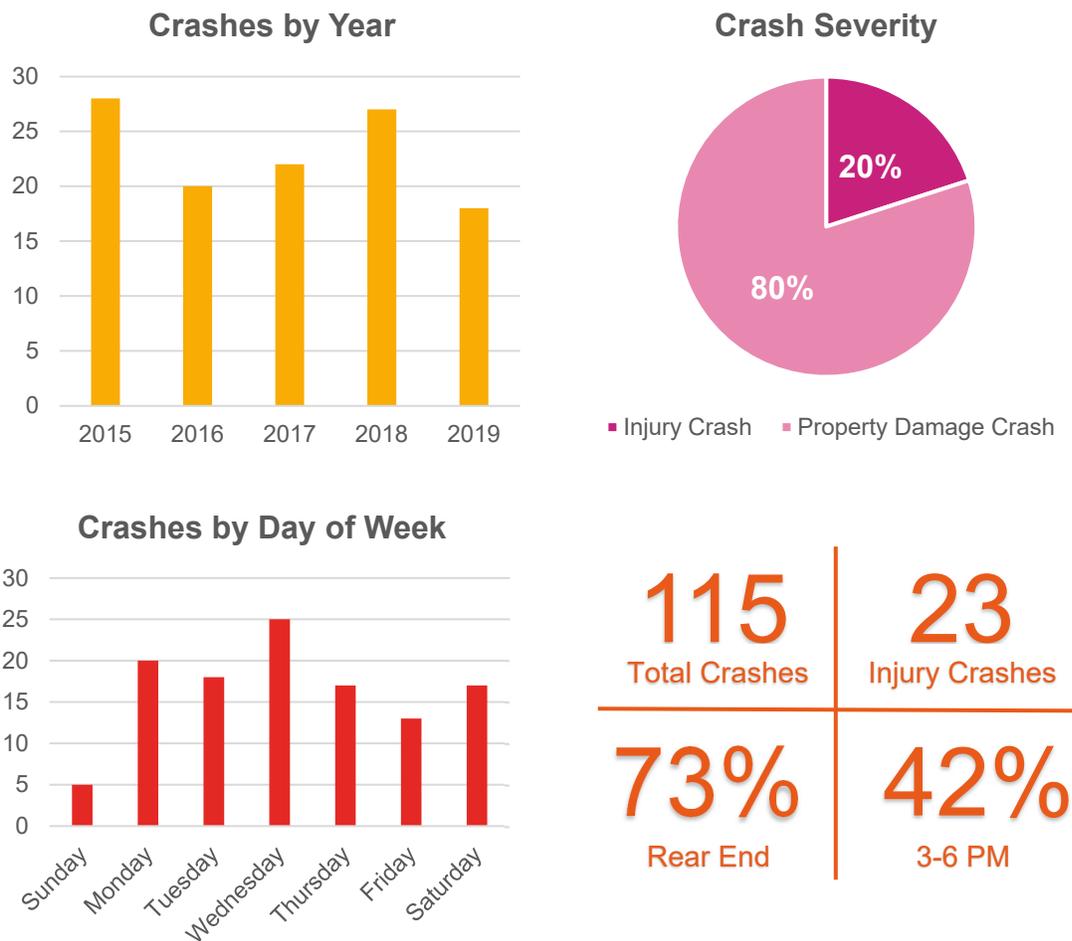
Figure 2 - 2015-2019 Crash Data Summary

Of the 115 crashes that occurred along the Clague Road corridor from 2015 to 2019, 23 resulted in an injury. Of these 23 injury crashes, there were 10 total minor injuries, and 3 incapacitating injuries. Generally, most crashes were low speed property damage only (PDO) crashes, with 67% of all crashes occurring at an officer estimated speed of 20 MPH or lower.

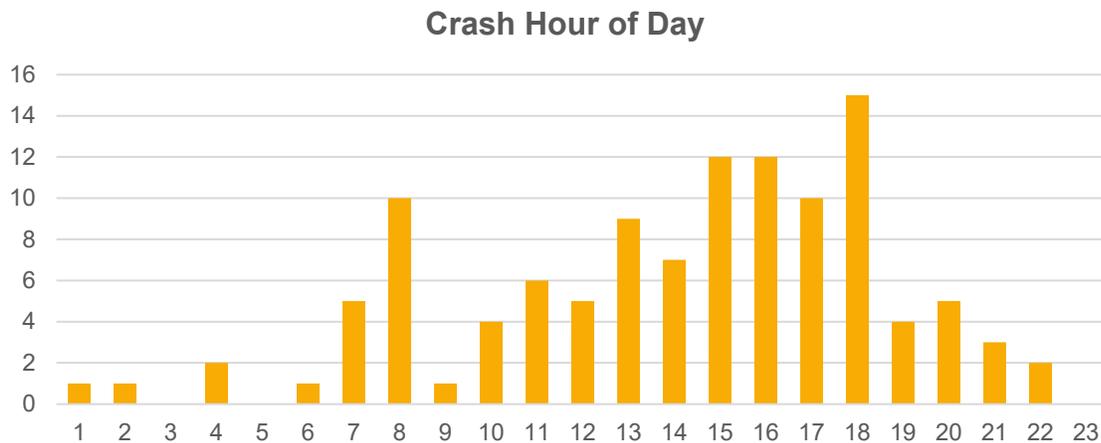
Figure 3 - Crash Distribution by Hour of Day

Overall, crashes occurred during peak periods, primarily during the PM peak of 3 PM to 6 PM (Figure 3). As a major cross-county commuter route connecting I-90 and I-480, it is not unusual to see higher crash patterns during peak periods.

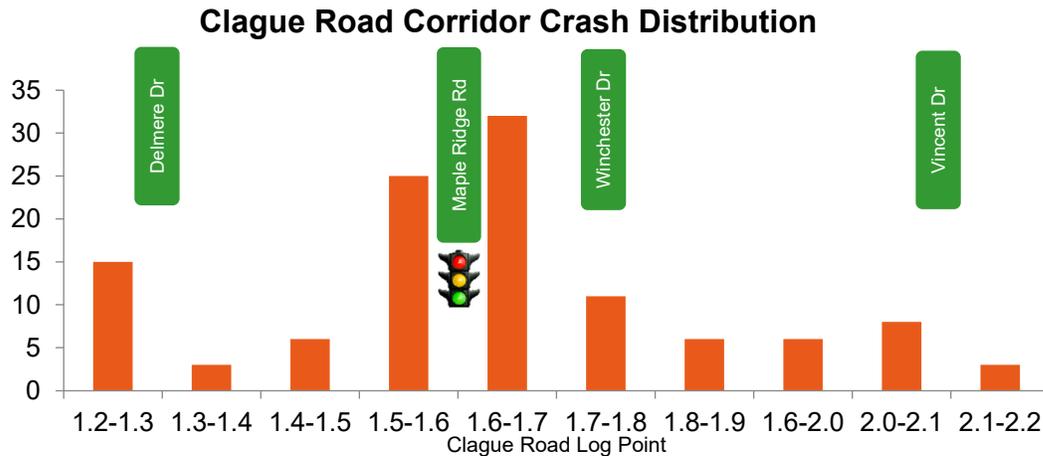
Figure 4 - Corridor Crash Distribution by Location

Mott MacDonald verified crash locations by comparing the data obtained through the GCAT system to location information in the actual crash report of each crash. After verifying crash locations, crashes were organized by their ODOT log point (shown previously in Figure 4). The corridor extends from approximately log point 1.2 to 2.2. A log point is a geographic reference to a specific point on a corridor, broken up here in tenths of a mile.

Of the 115 crashes observed from 2015 to 2019, roughly 50% occurred at the Maple Ridge Road intersection. Another 16% occurred near the Delmere Drive intersection, and approximately 15% occurred between Stoneybrook Drive and Vincent Drive, which is a 600 ft stretch of the Clague Road corridor containing four TWSC T-intersections.

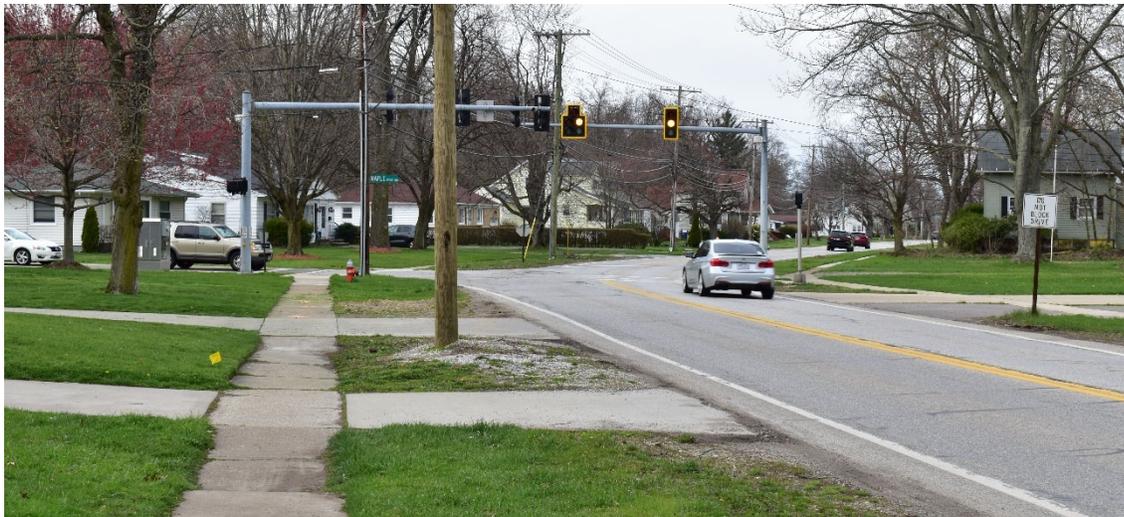
Figure 5 - Northbound Approach to Maple Ridge Road

Between 2015 and 2019, there were 48 crashes between Frank St/Sharon Drive and Carriage Lane, including the Maple Ridge Road signalized intersection (Figure 5). Of these crashes, there were 6 injury crashes.

The predominant crash type at the intersection was rear end, which represented 80% of all crashes between these three intersections. Of the 48 crashes, 23 crash reports (48%) specifically cited the crash location as the Maple Ridge Road intersection. While only half of the crashes specifically cited the Maple Ridge Road intersection, queueing at the intersection routinely backs up to Frank/Sharon for northbound traffic, and to Carriage for southbound traffic. The lack of a dedicated northbound left turn lane and related signal inefficiencies are likely impacting the crash pattern, with vehicles stopping at the signal being rear ended by vehicles unaware that the car in front of them is stopping to complete their turn.

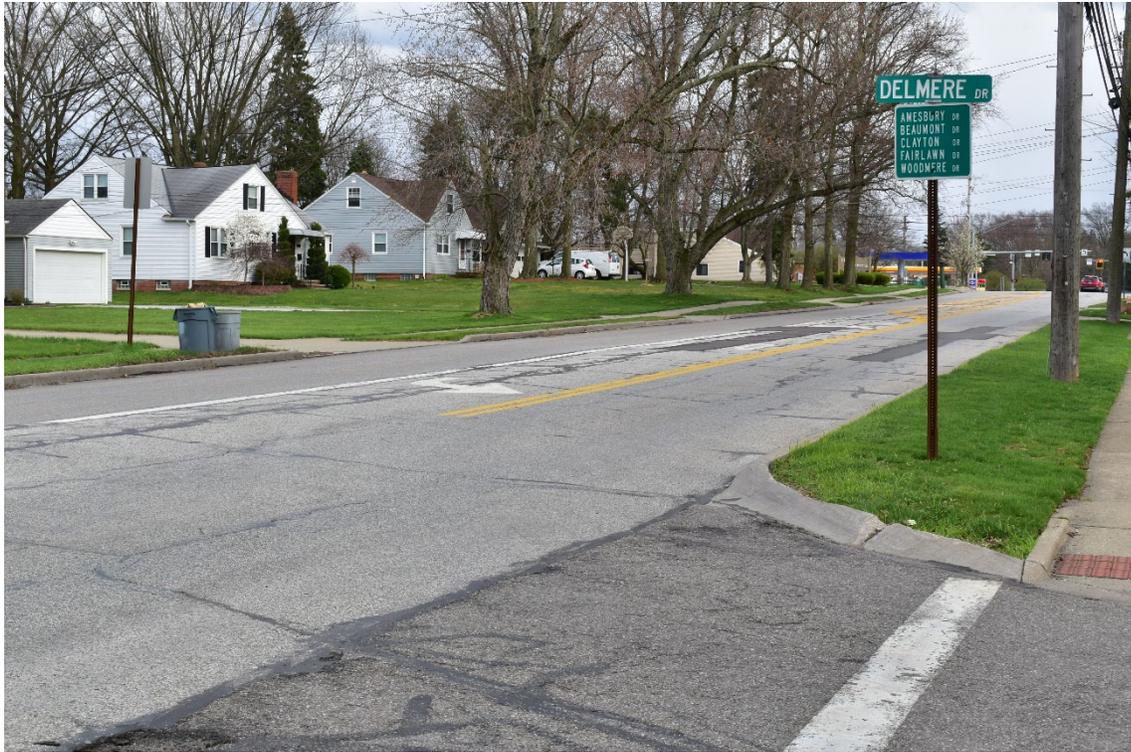
Figure 6 - Delmere Drive Intersection

A dedicated left turn lane allows vehicles turning left from the northbound direction to exit the thru lane and allow northbound thru traffic to continue unobstructed, reducing the risk of rear end crashes caused by turning movement demand.

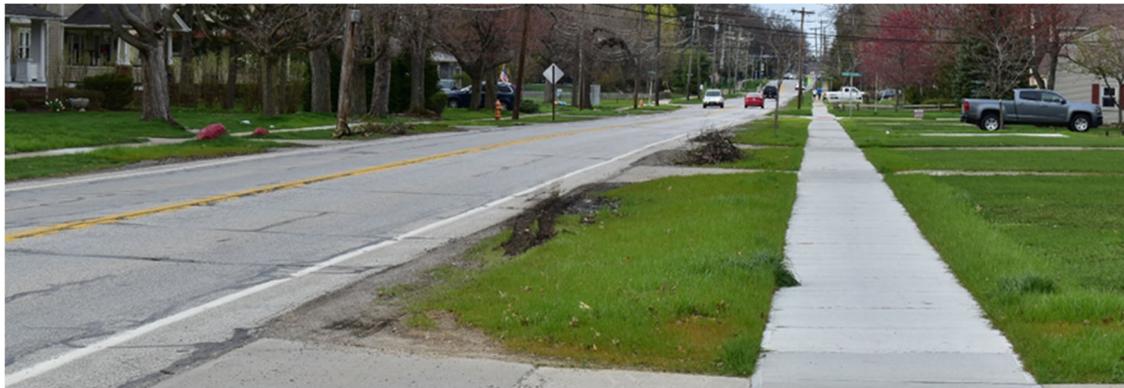
Figure 7 - Clague Road Northbound Approaching Stoneybrook Drive

There are no open ditches along the corridor for water collection and storage, but there is a closed system with inlets along the east and west side of Clague Road. Examination of the cross-section and drainage properties of Clague Road is warranted, and consideration of a curbed section with curb inlets may be necessary.

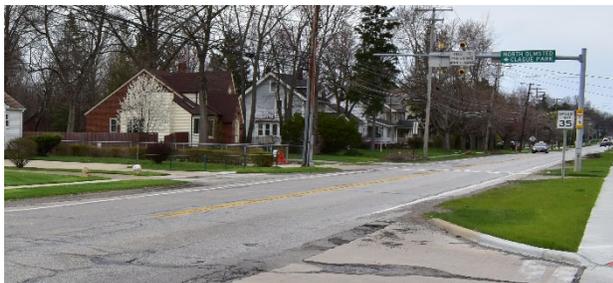
Figure 9 - Alexander Drive SB Approach

At each intersection analyzed, the AM and PM peak warrants were met for the 5% left turn curve. While these left turn lane warrants were met, there are multiple factors which go into whether to install left turn lanes at an intersection.

of the intersection. While a left turn lane may be desirable for southbound movements, even the minimum recommended left turn lane length (100ft) would impact the pedestrian crossing, and potentially place the left turn lane inside of this crossing, which is not desirable for pedestrians or bicycle users.

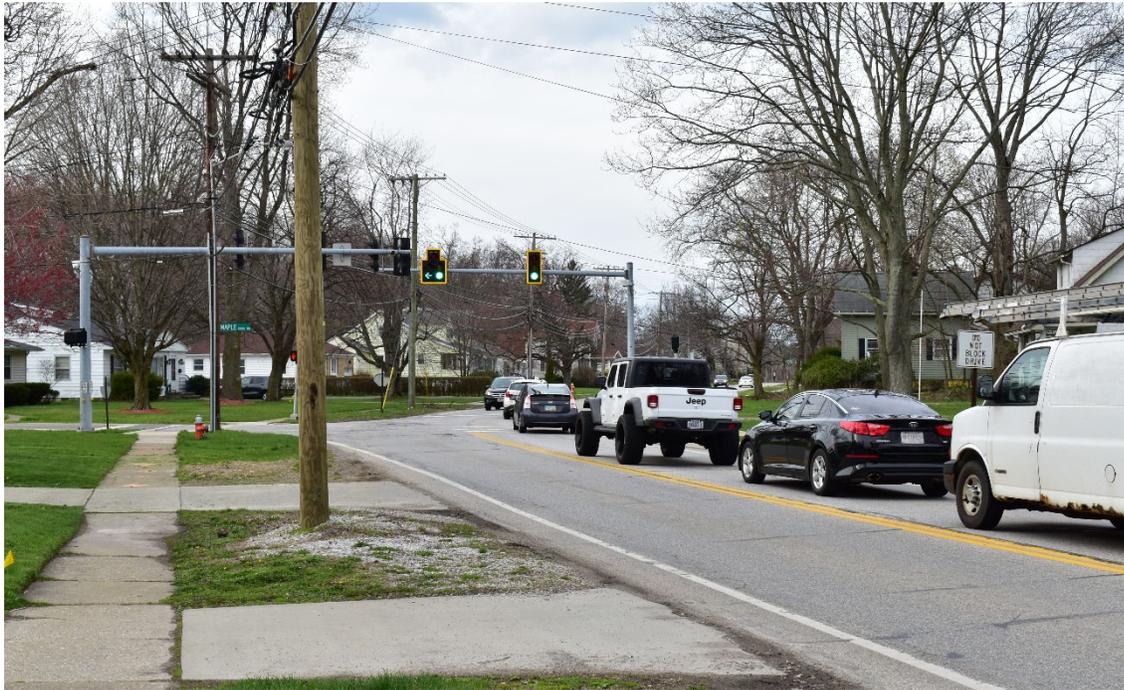
Figure 10 - Maple Ridge Road from Frank Street/Sharon Drive (Facing North)

Similarly, at Frank Street/Sharon Drive (Figure 10), there is approximately 250 feet between the intersection and the signalized intersection at Maple Ridge Road, north of Frank/Sharon. A left turn lane for the southbound movement to Sharon Drive may be desirable but may also impact the length of any left turn lane proposed at Maple Ridge Road.

In the northbound direction, a left turn lane to Frank Street may be confused by drivers as the left turn lane to Maple Ridge Road. Vehicles entering the left turn lane thinking that it continues to Maple Ridge Road may be surprised to see a vehicle stopping short to turn left onto Frank Street, creating the potential for crashes.

At Frank Street and Sharon Drive, a northbound left turn lane for Frank Street may be confused as the beginning of a left turn lane for Maple Ridge Road. In this case, if a southbound left turn lane were provided for Sharon Drive, this condition would also produce a potential head-on risk.

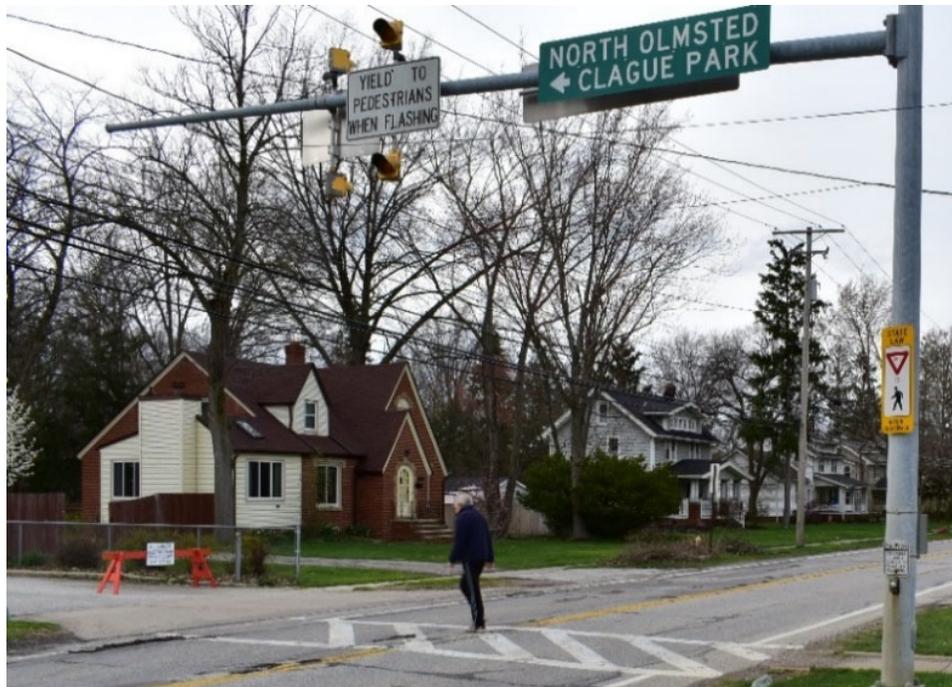
Figure 11 - Clague Park Mid-Block Crossing

There are two locations within the study area that provide marked crosswalks for east-west pedestrians across Clague Road. One of these locations is at Maple Ridge Road, where pedestrian countdown heads and pushbuttons are provided. The second is a pushbutton actuated flashing beacon and mid-block crossing at Clague Park (Figure 11).

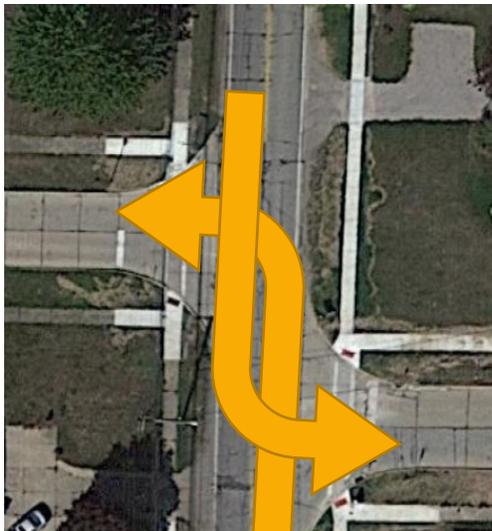
Figure 15 - Opposing Left Turn Movements at Ambour Drive/Winchester Drive

A center two-way left turn lane (TWLTL), as proposed for the study corridor in Alternative 2, provides noticeable operational benefit but introduces some geometric and safety concerns. This is most notable at along the corridor where a TWLTL could produce head-on movements.

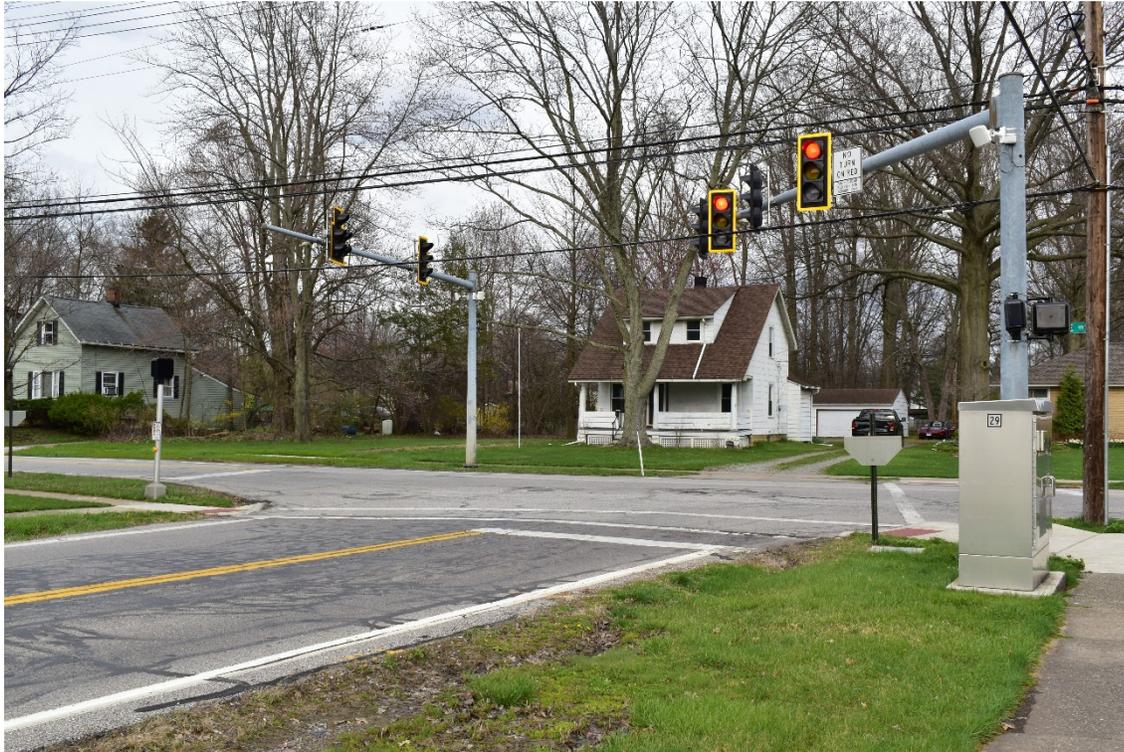
**Figure 16 - Maple Ridge Road Eastbound Approach to Clague Road
(Note the Signal and Utility Pole on the Right Side)**

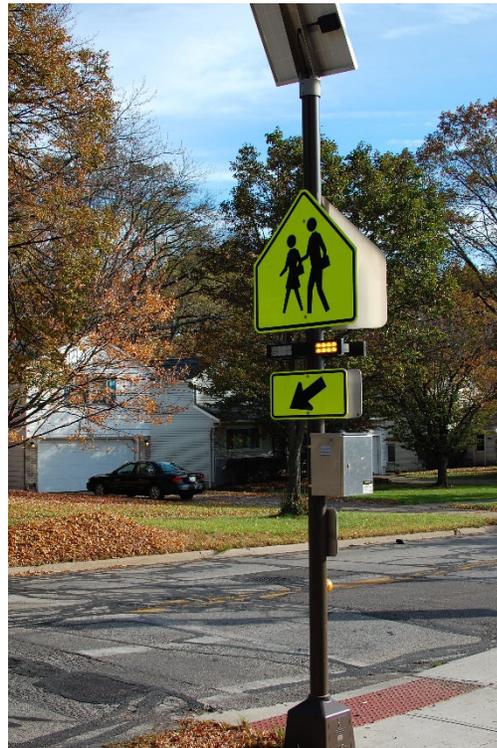
Figure 17 - Example RRFB

RRFBs are commonly installed at mid-block crossings, and near schools or along known school routes, such as the installation in Figure 17, installed along W 210th Street in Fairview Park.

RRFBs are installed on the near side of the crosswalk (as approached by a vehicle). The existing driveway apron for Clague Park may constrain the location of the RRFB as a result, requiring the proposed crosswalk to shift several feet either north or south of the existing crosswalk. This would take the crossing out of alignment with the existing walk leading into Clague Park, which may be unfavorable to pedestrians.

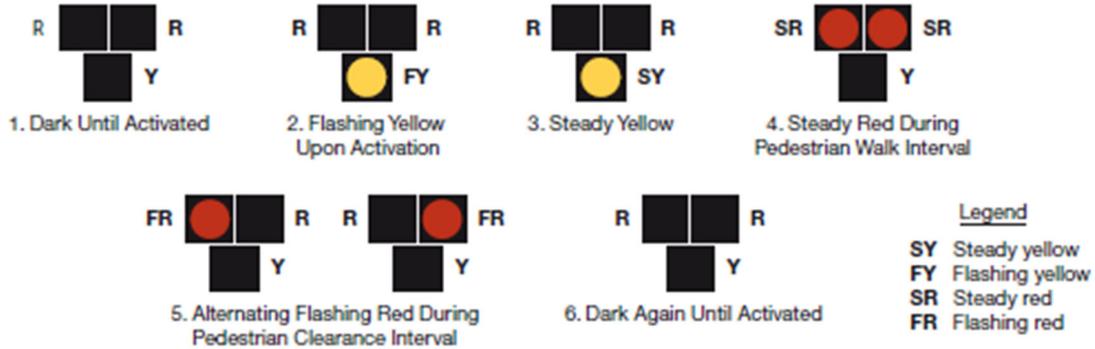
Figure 18 - Typical PHB Activation Sequence (FHWA)

between a PHB and a typical traffic signal is its operation. The PHB remains dark when not in use, and only illuminates when actuated by a pedestrian.

When actuated by a pedestrian, the PHB cycles through a pre-timed sequence of flashing yellow, solid yellow, solid red, and flashing red indications alerting oncoming vehicles of a pedestrian movement (Figure 18). Signage mounted to the mast arm directs vehicles to stop on a solid red indication, allowing safe passage of the pedestrian.

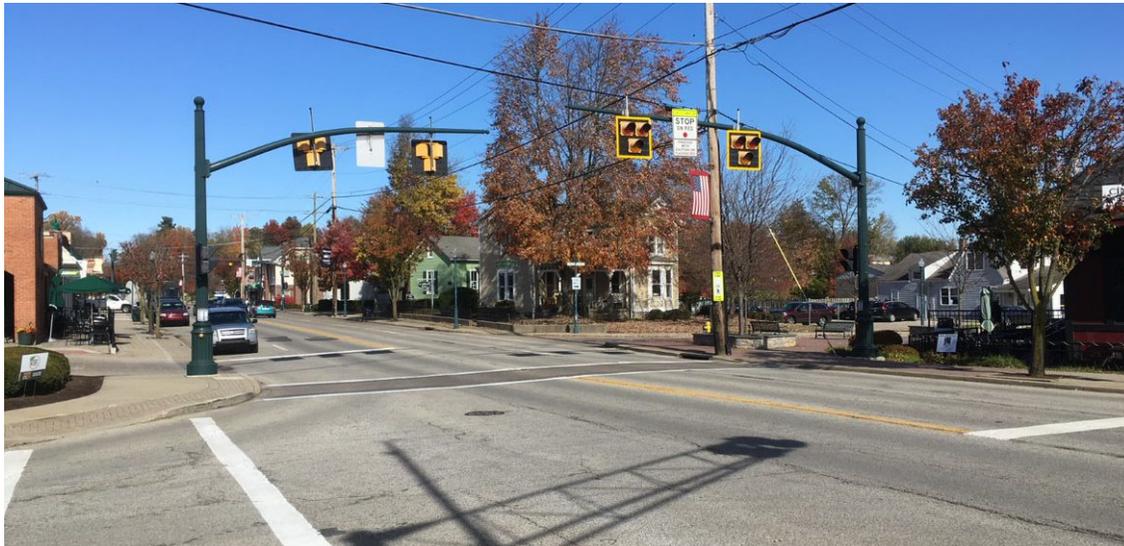
Figure 19 - Example PHB

By providing a solid red indication, a PHB directly reinforces the requirement of stopping to allow pedestrians to pass through the crossing, which improves overall crossing safety. A PHB is also a visible indication that will stand out, identifying the entrance of the park and the presence of a pedestrian crossing against other signs and side streets, including Alexander Drive which is approximately 150 ft to the south of the crossing.

The Federal Highway Administration (FHWA) identifies PHBs as a Proven Safety Countermeasure, and nationwide research shows an average reduction in pedestrian crashes of over 50%, and a reduction in serious injury and fatal crashes of 15% at locations where a PHB

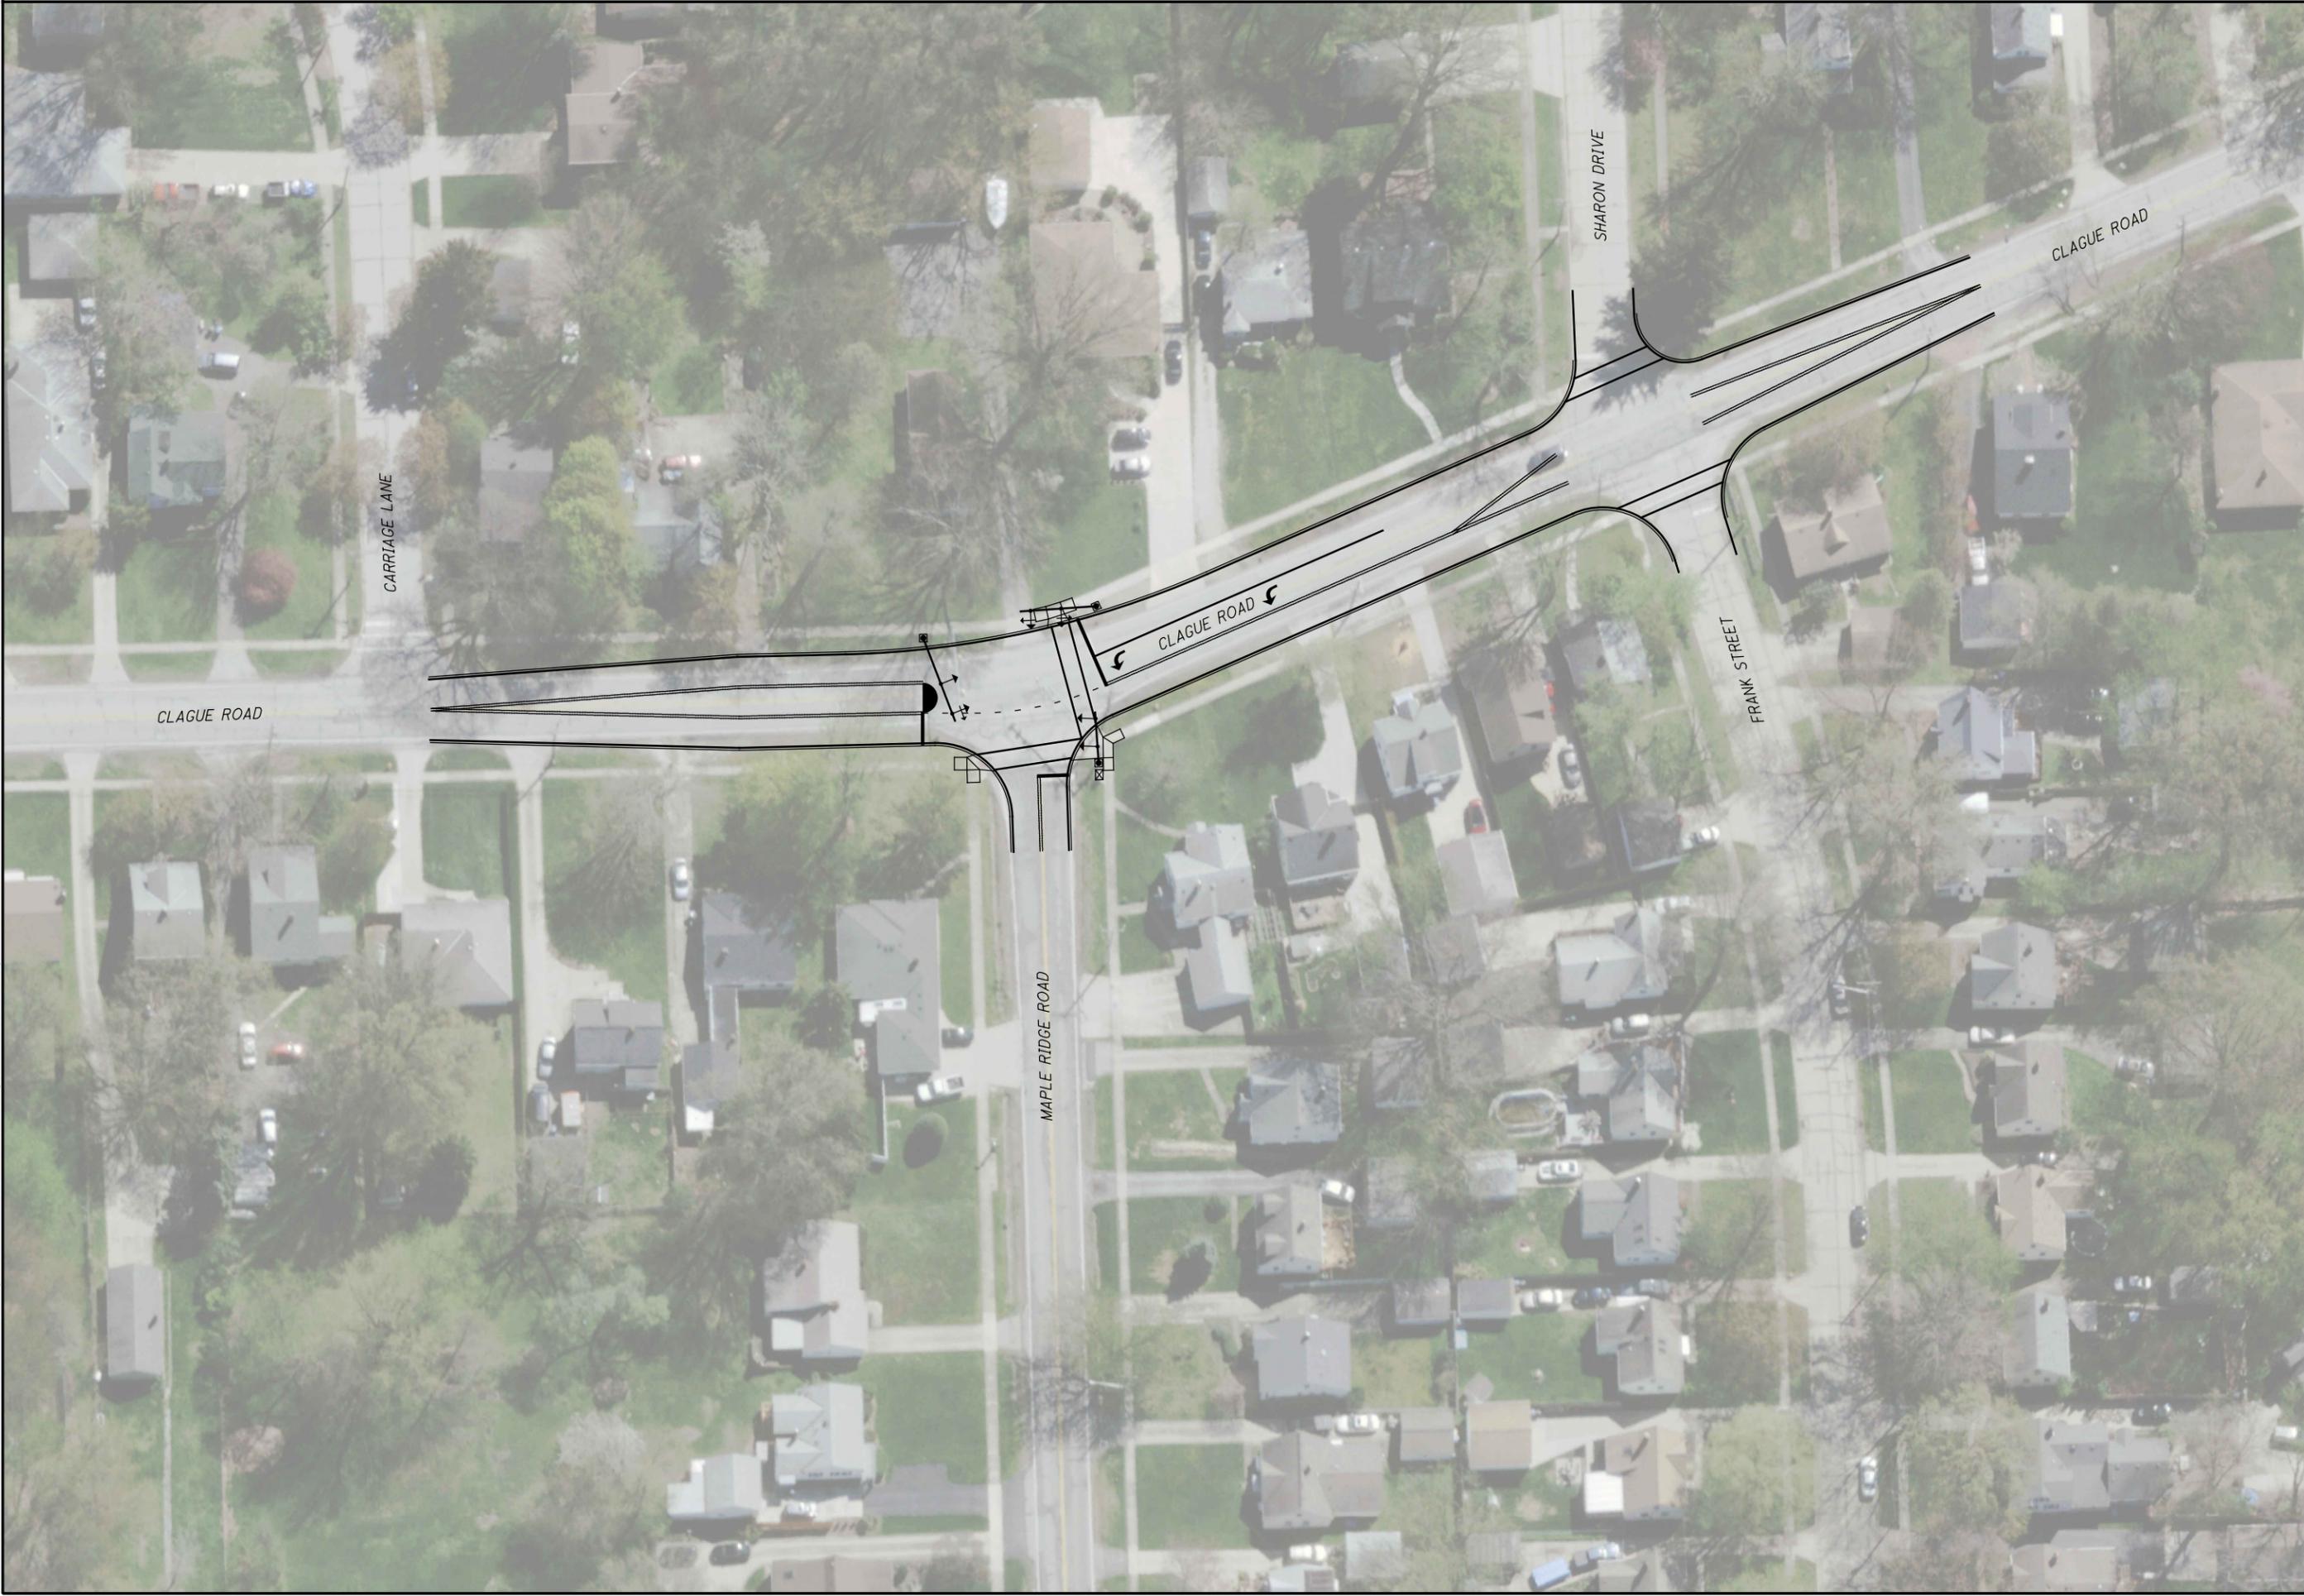
CLAGUE ROAD · SAFETY STUDY
 MAPLE RIDGE ROAD PROPOSED ALTERNATIVE

- Install northbound left turn lane
- Install curb along intersection approaches with drainage inlets tying into existing system
- Replace the existing signal (if necessary)
- Adjust signal timing and phasing to accommodate new traffic signal
- Replace curb ramps

Figure 20 (Clague/Maple Ridge) and Figure 21 (PHB) present the recommended countermeasures.

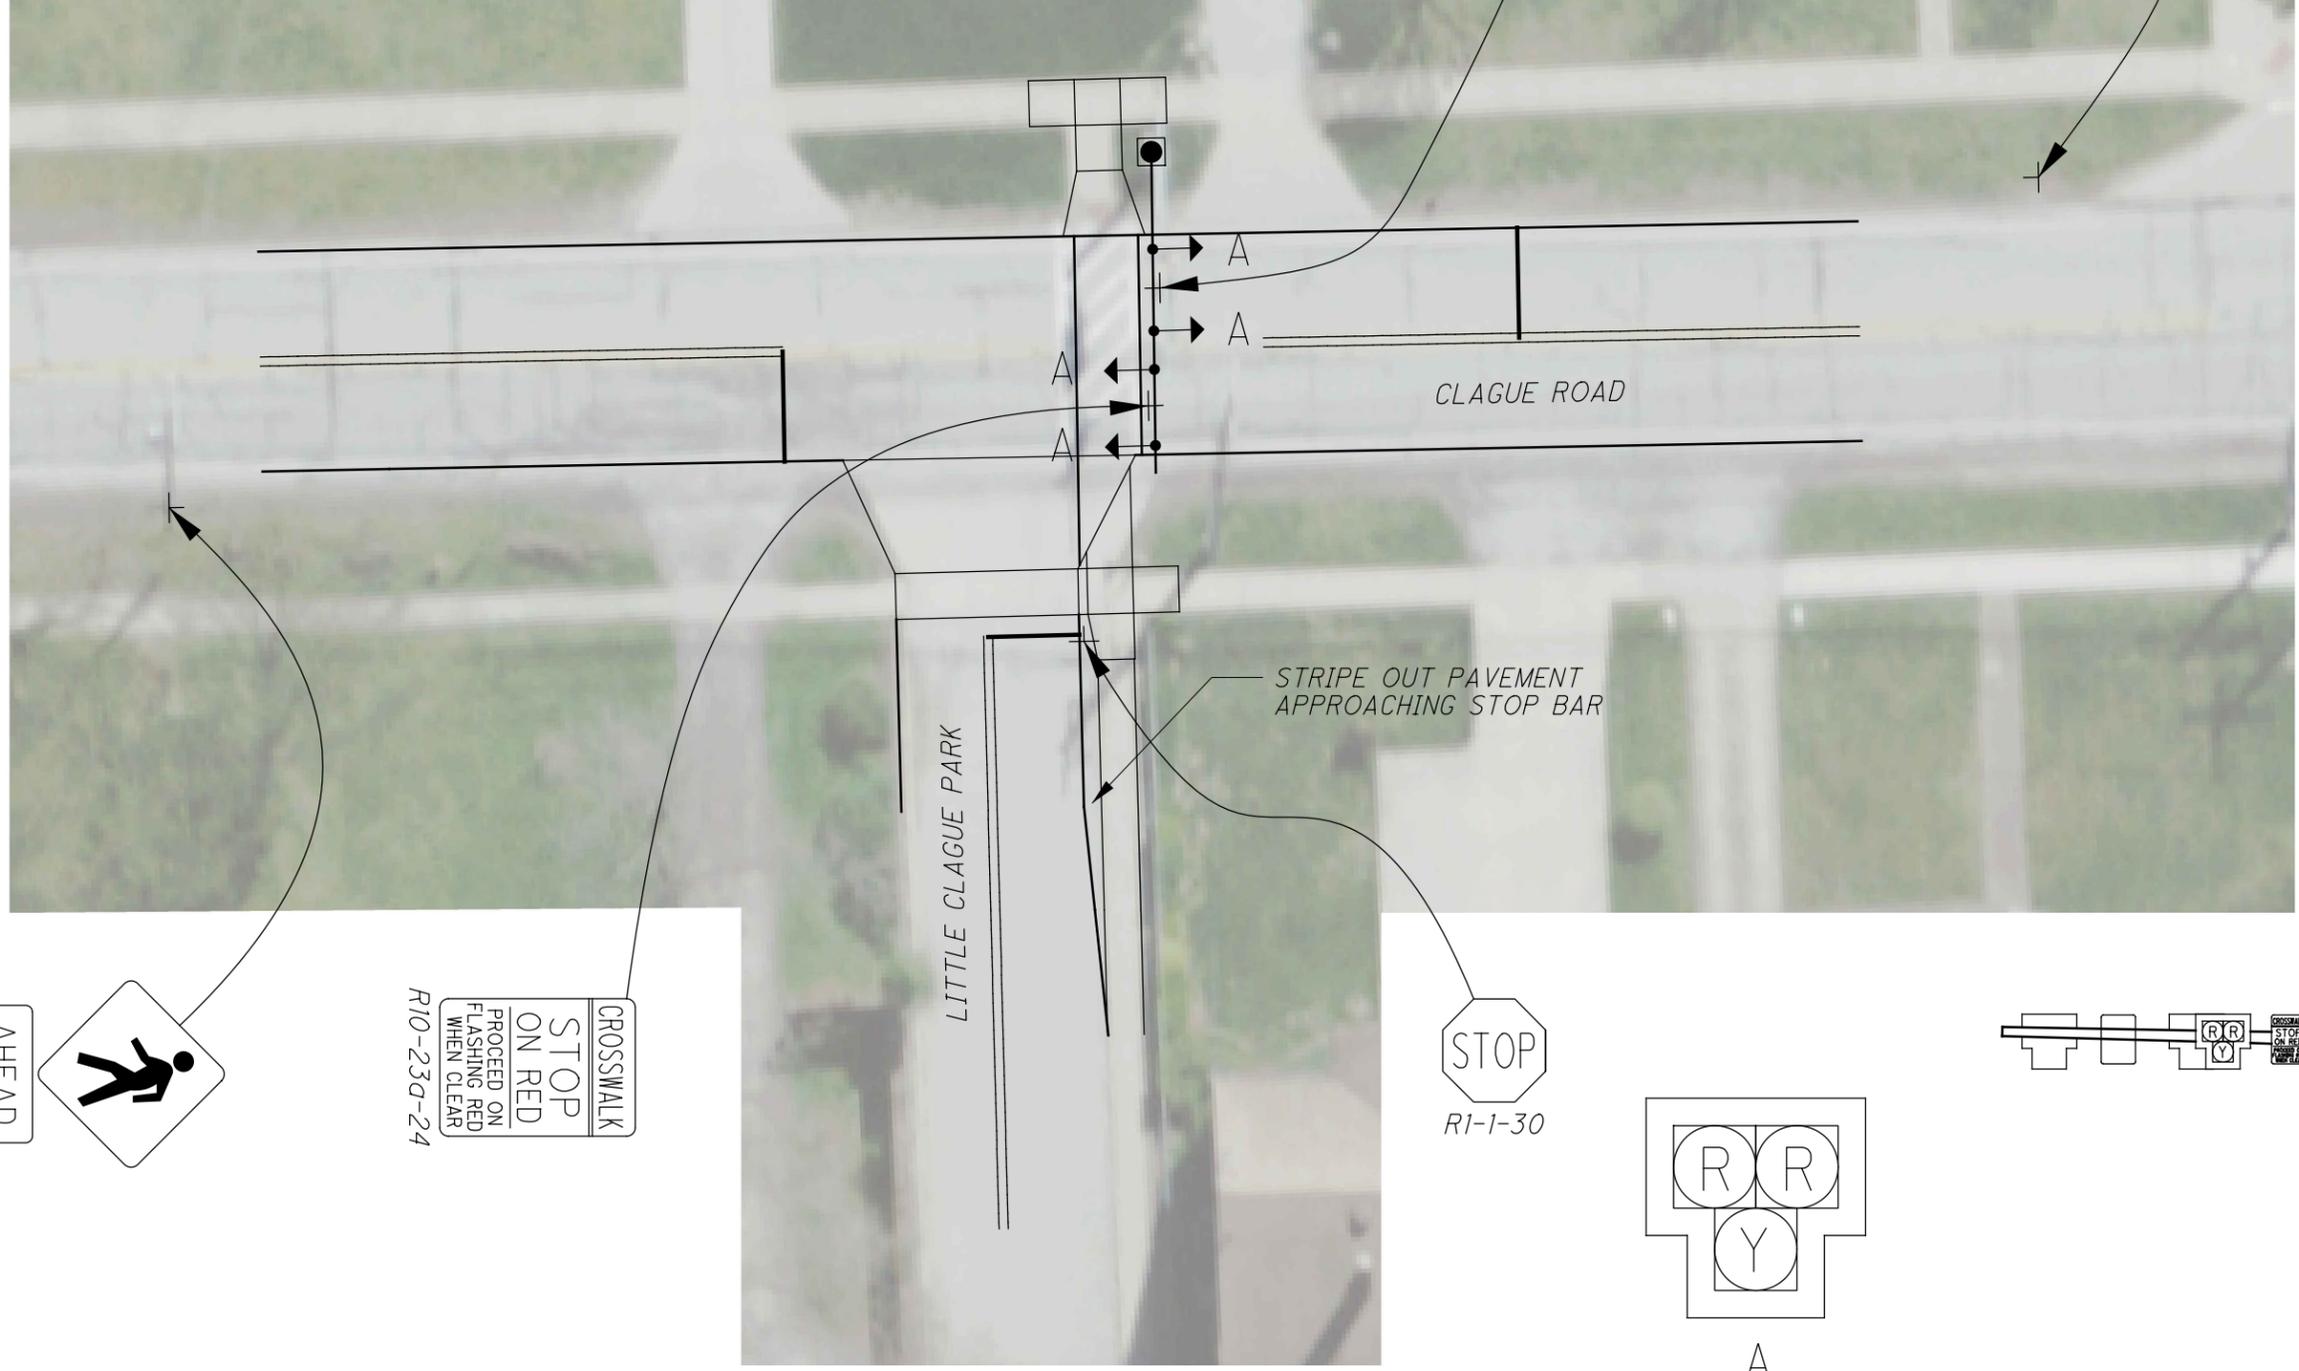
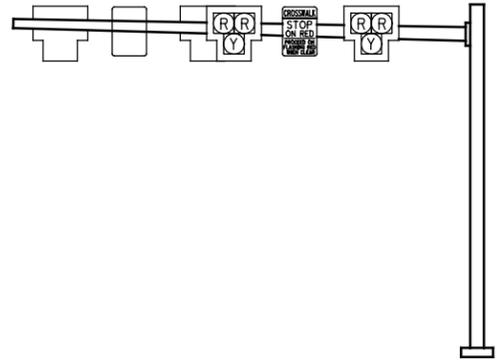
CLAGUE ROAD · SAFETY STUDY
LITTLE CLAGUE PARK PROPOSED ALTERNATIVE

- Install pedestrian actuated Pedestrian Hybrid Beacon (on new mast arm if necessary)
- Install curb along approaches to PHB
- Install advance pedestrian crosswalk signage
- Replace and align curb ramps
- Replace Clague Park driveway apron

PEDESTRIAN HYBRID BEACON
SIGNAL HEAD
